Fixing and Linking Our Wetlands (FLOW) Project
Selsey Parish
Ditch condition assessment results and habitat
improvement plan 1.0

Jane Reeve and Christopher Drake
Manhood Wildlife and Heritage Group
March 2021

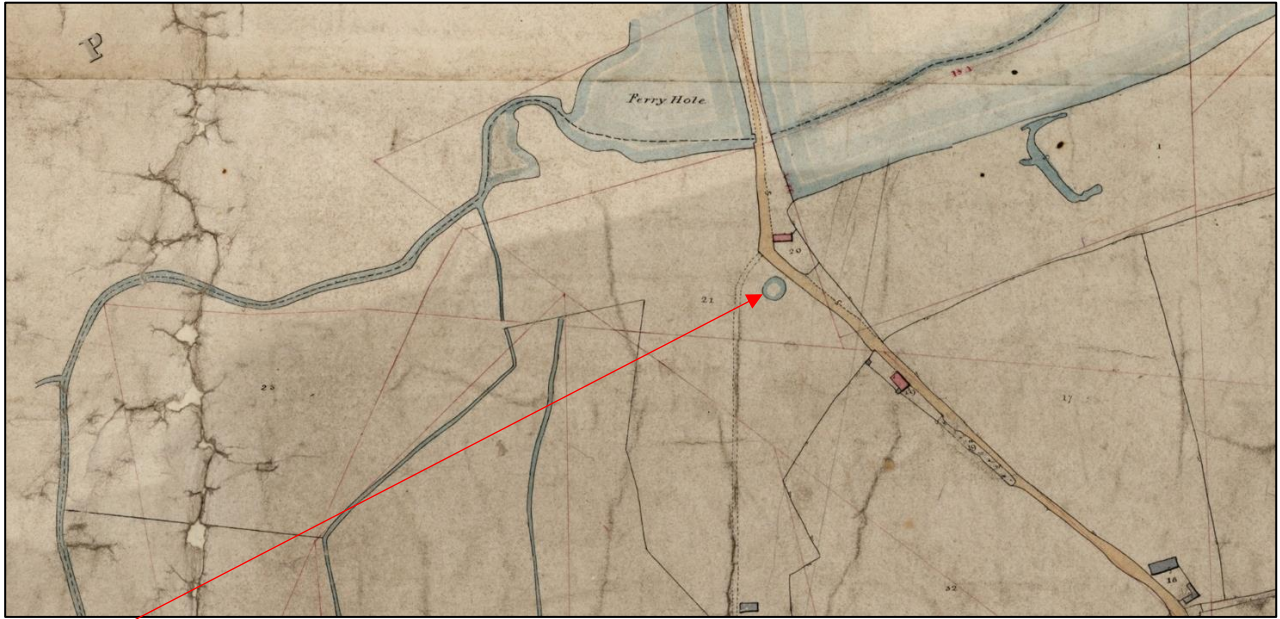
The tithe map illustrates Ferry corner pond that is currently drying out and is at risk of being lost.

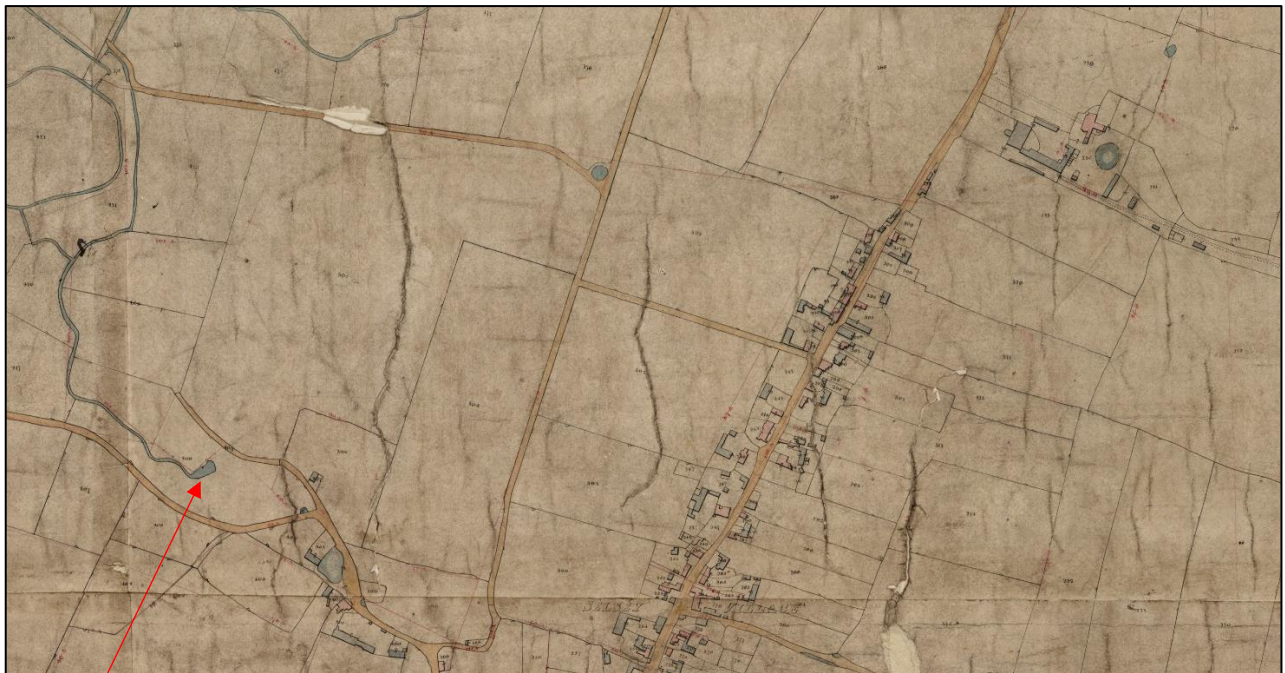
Pond at Crablands meadow

The tithe map indicates the relic pond at Crablands meadow that is now a wet willow carr in the field.
