Appendix iv: Example photos of work carried out as part of WSCC OW funding and FLOW completed work

Drainage and Environmental Improvements – carried out / funded by FLOW

Appendix iv: Example photos of work sites
Fixing and Linking Our Wetlands
Sidlesham ditch condition assessment results and
habitat improvement plan

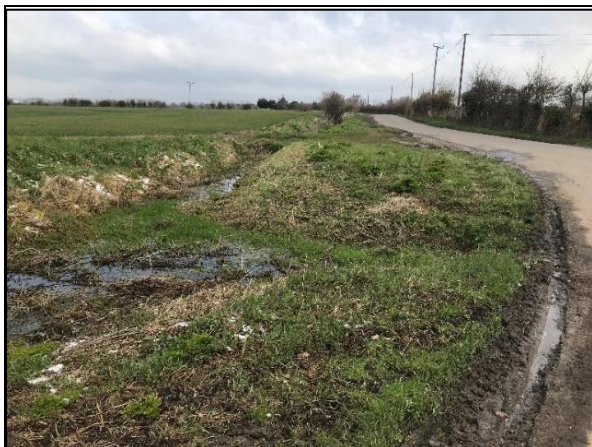
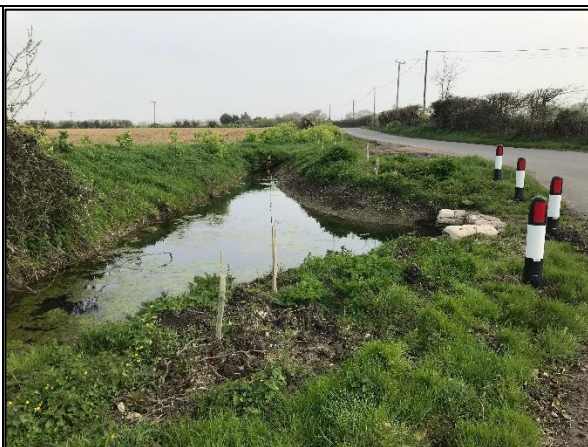
Before	After
<p>Sheepwash, Ham Road - Relic pond completely dried out and lacked management. Needed to have the willow, bramble and nettle removed and be dug out and the original pond outline re-established. This has significantly benefitted Ham Road which significantly floods each year and will also add to the biodiversity.</p>

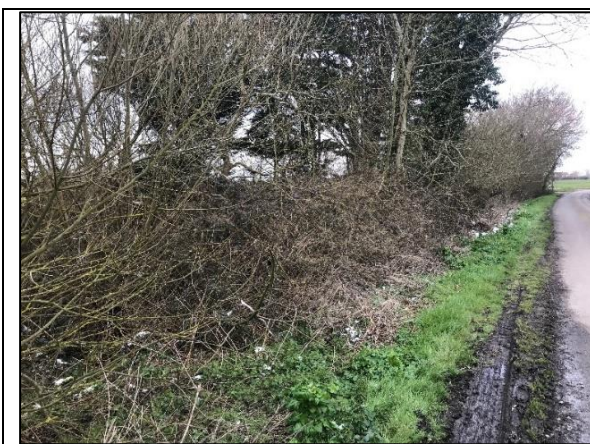
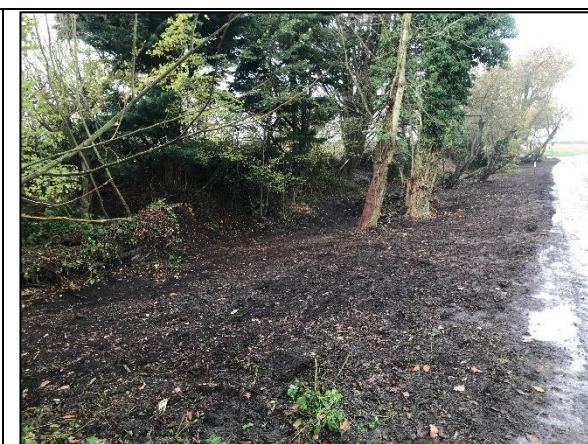
Corner pond / ditch area opposite The Elms – A junction area just before a culvert that carries water underneath the road. This was a large pond on the verge corner and had slowly been filled in. By reinstating it as a pond again with a grip off the road, this has helped with flooding on this road junction.

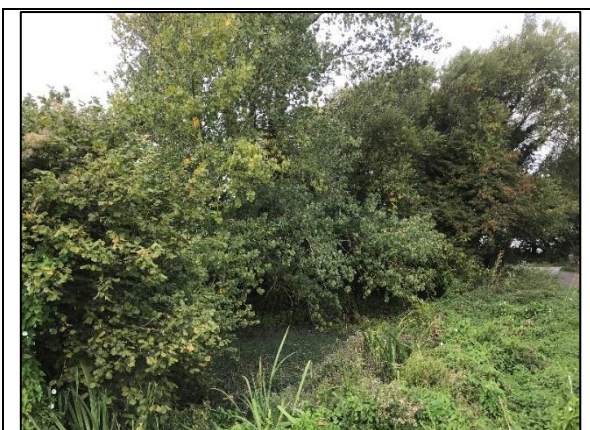
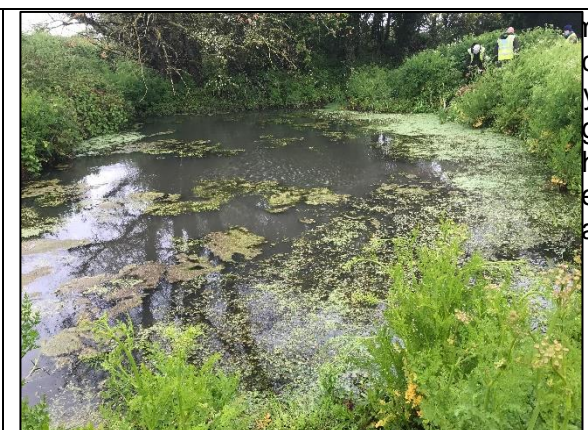
The Elms ditch - This is a large wide ditch full of broken-down old trees, debris from previous trees falling, bramble and undergrowth. This area frequently floods, so by digging the ditch out and increasing its' capacity, it will be able to tank more water. This corner ditch when opened up and light let in will host more diverse vegetation. A grip off the road has taken water into the ditch to help reduce road flooding.

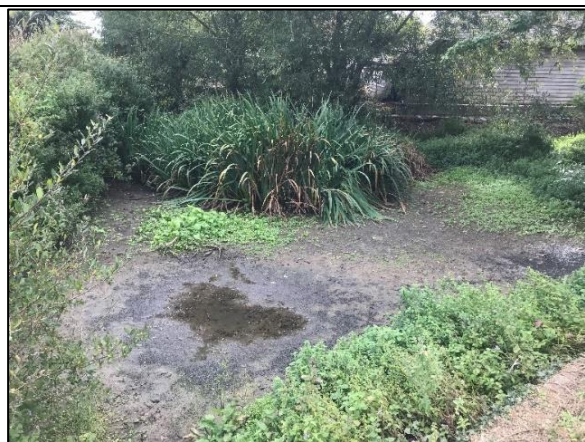
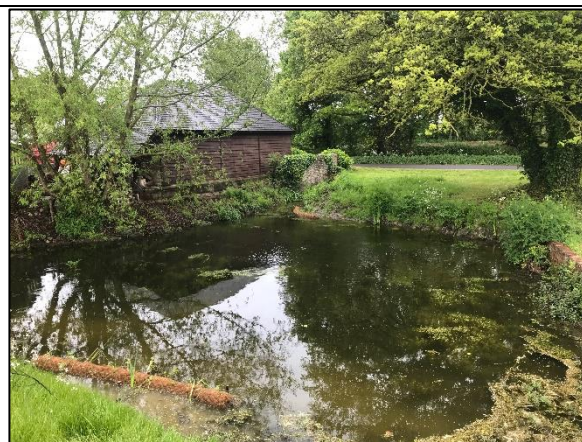
Mapsons Farm pond - This farm pond had shallowed out with silt and was dark and shaded out. After digging out the pond and removing key overhanging branches, it holds more water and therefore prevents the road from flooding. It has also added to the biodiversity of both pond and banks.

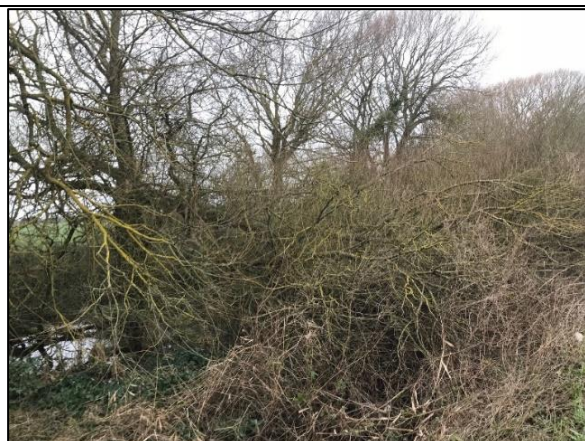
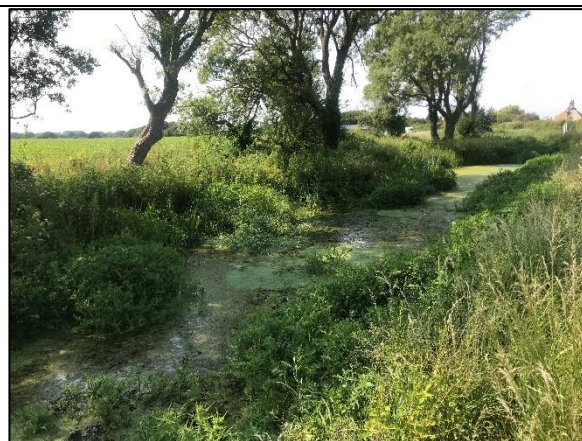
Sheepdip pond - This pond with historic value previously had water voles on it but has been so full of silt in recent years that it has dried out and has been so overwhelmed with flag Iris and other wetland plants that there was no open water. Digging it out and deepening has allowed the pond to remain wet for longer and beneficial – new wetland plants can then be added.

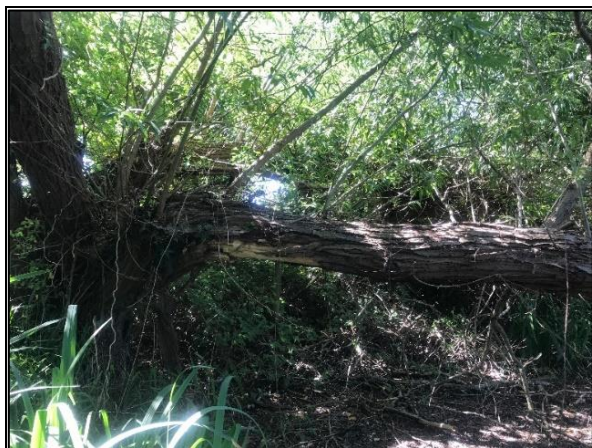
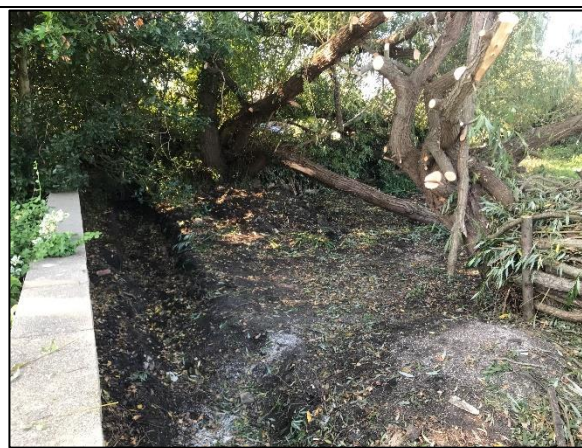
Willow Glen wetland - Large relic wetland area that was originally part of the tidal mill reedbeds. It had been cut off with partial reclamations and the B2145. Large mature willow and bramble dominated, and a large amount of silt build up. It was dug out to be a large pond again and wetland plants added. Now holds water for long periods and is a biodiversity hotspot with the addition of wetland plants.

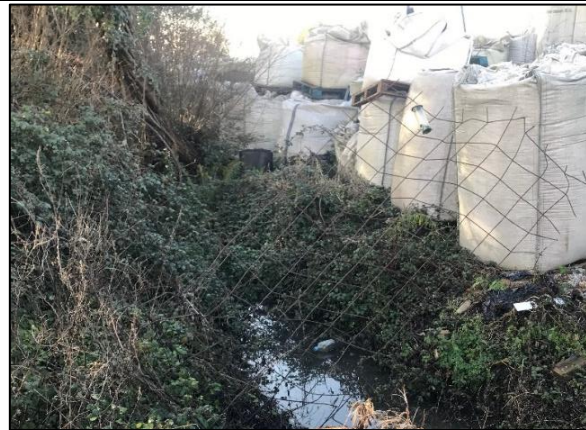
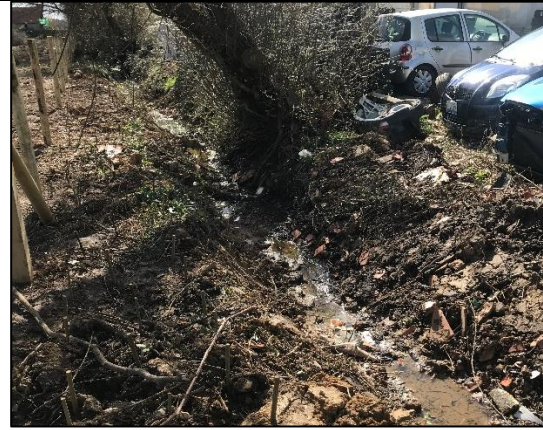
Chartwood Nursery Pond – this pond on a private plant nursery site and adjacent to a main road was overgrown and an incoming culvert was blocked that backed up and contributed to significant flooding on the B2145. Opening-up this pond, increasing its capacity, and digging out the adjacent ditches, combined with an investigation of the nearby culverts and road gullies has solved local flood issues while creating a nice pocket of wetland.

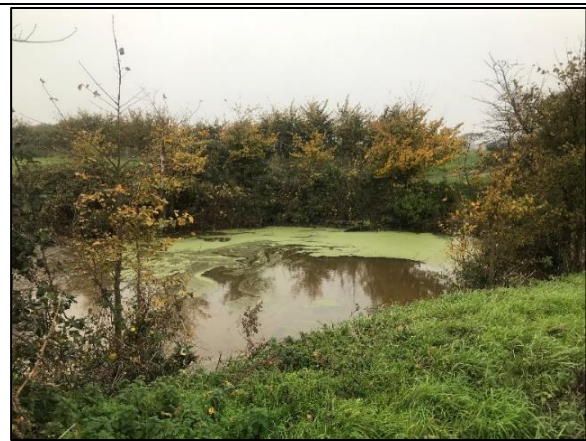
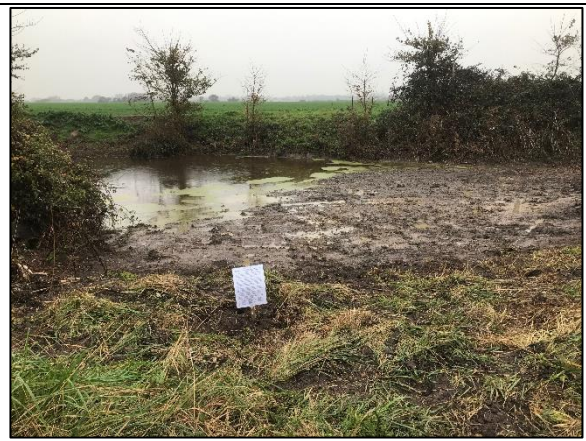
Cherry Tree Farm – this site has ditches on 2 sides but hasn't been managed in recent times and is not connected to the network. Managing them, removing the build-up of rubbish and connecting them has provided better habitat and drainage. Hedges planted around the site has improved soil permeability and should also reduce surface water runoff.

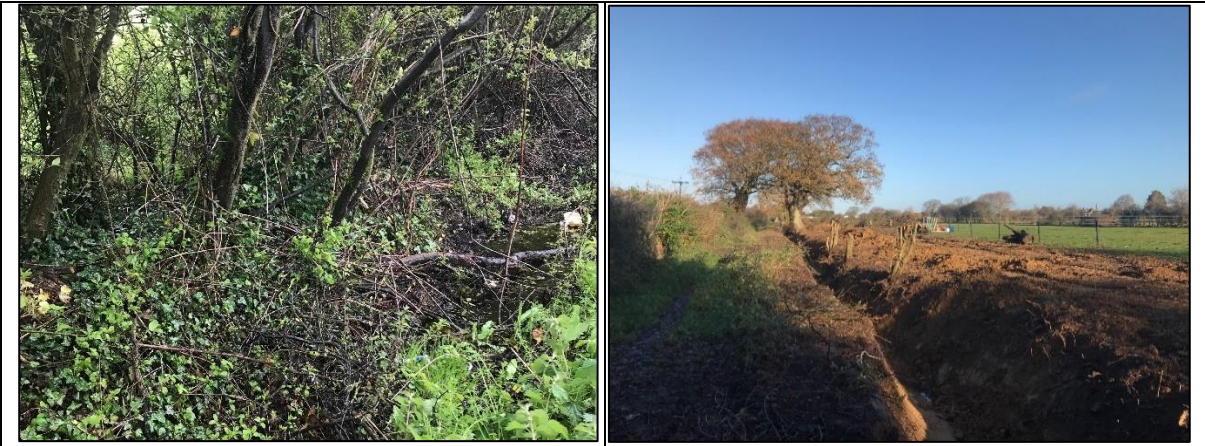
Sidlesham Common Ditches – ditches recovered to re-join the wetland system to the network and reduce the groundwater levels
