Appendix iv: Example photos of findings  
 Fixing and Linking Our Wetlands  
 Earnley ditch condition assessment results and habitat improvement plan

Appendix iv: Example photos of findings

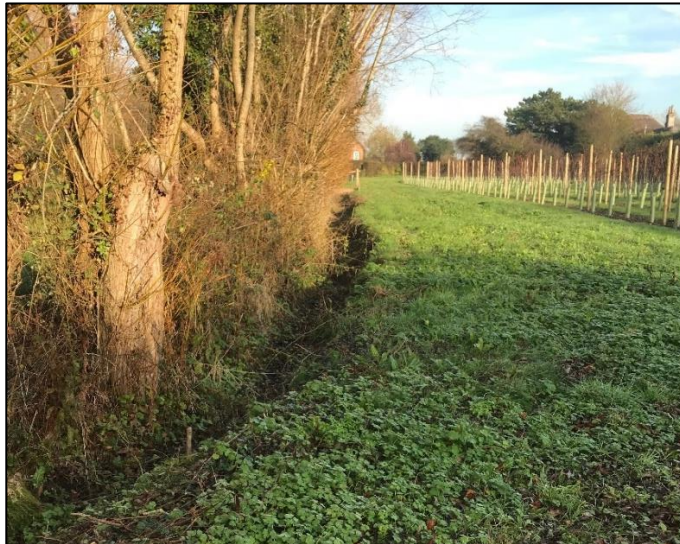
**Sparrow Cottage** – By digging out this ditch and an adjacent pond area, the tanking ability of this site will improve during high rainfall events and hold water away from the property. It will also benefit wildlife. Laying the willow and planting other tree species will also keep the banks stabilized, utilize the water and provide food and habitat for a range of species. It will also improve connectivity to the east and north of the cottage.

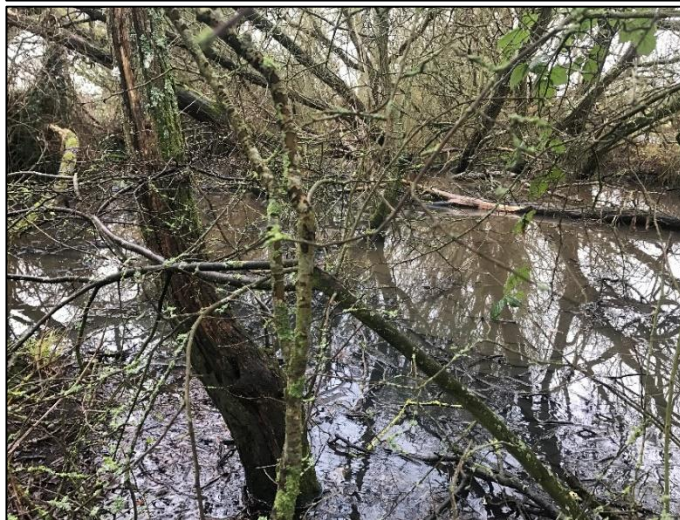
**Haydons Pond** - By improving the pond, it will be able to take more water off the Batchmere Road, where there has been a high incidence of flooding in the past. By opening up one side of this pond, the habitat would be improved, and it could become an attractive site for water voles as it holds water most of the year.

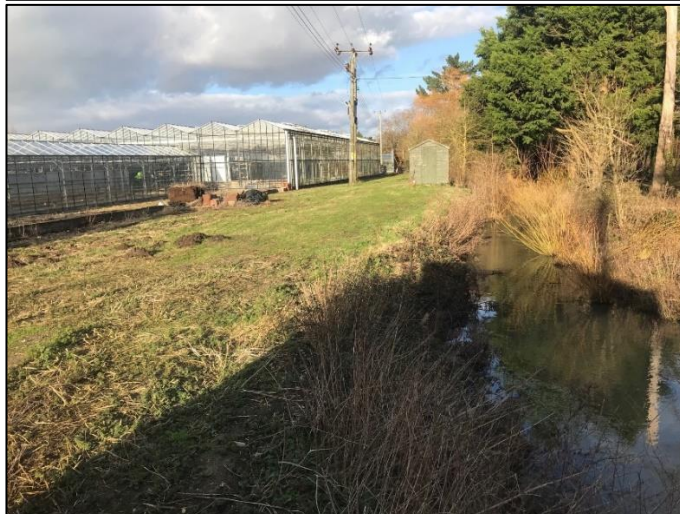
**Biotope Nursery** – By holding back water on this site it will prevent inundation of the rife during high rainfall events. The raingarden also acts to filter out debris and pollutants as water passes through it while also providing a new habitat - therefore it has both environmental and drainage benefits

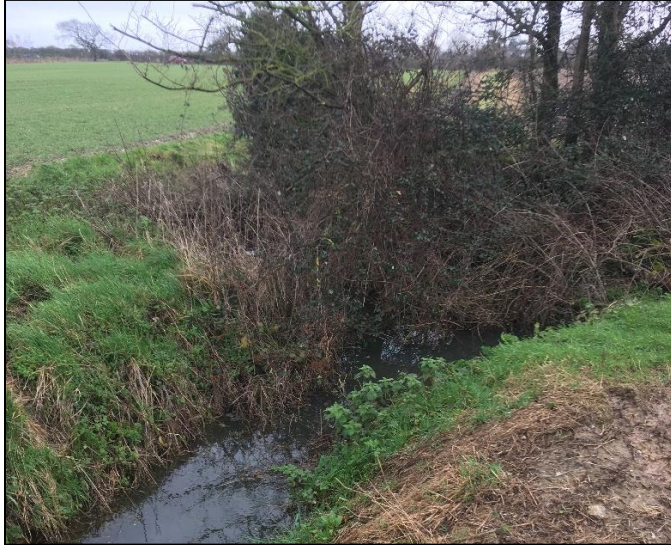
**Cherry Tree Farm** - With management the ditch would hold water for longer, have more capacity and be better habitat for wildlife.

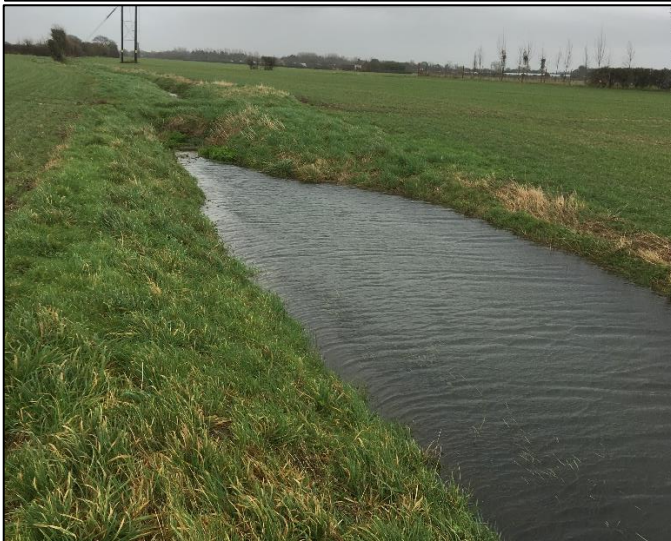
**Cathegena Farm** - A couple of the ditches were dry and full of debris when most other ditches were holding water. Digging out the junction area would have benefits for water storage and wildlife.

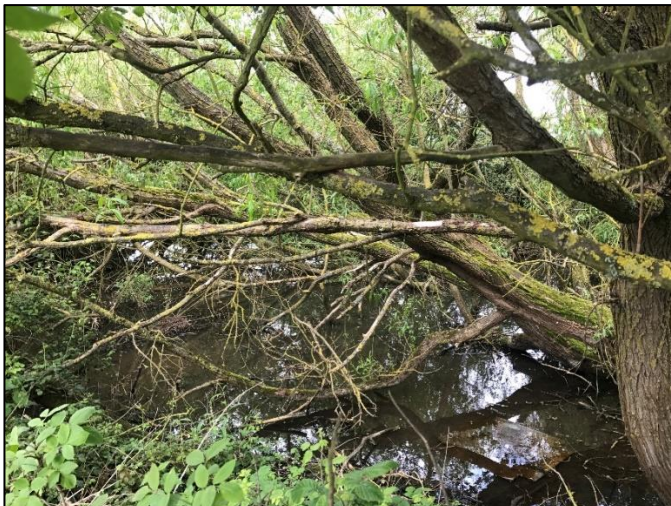
**Somerley Lane** - The ditch system flows south into a pond adjacent to Somerley Lane and flows into Sparrow Cottage. The pond is over shaded by Willow and holds little conservation value. The pond also contains a high percentage of silt in the Northern corner.

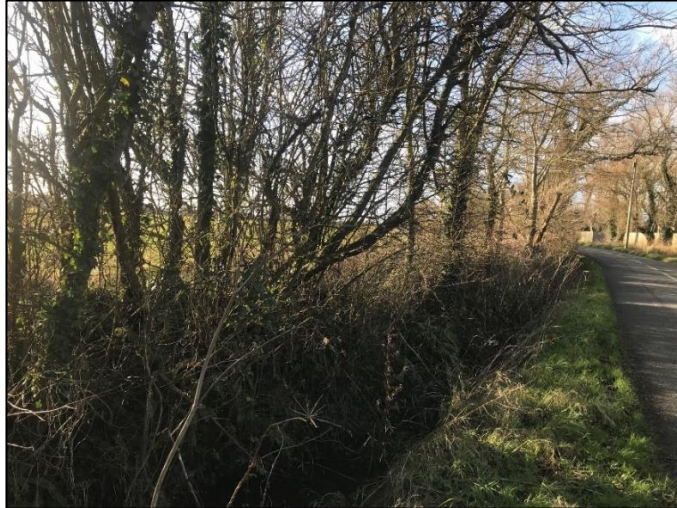
**Almodington Lane south** - The ditch on the roadside frequently contains rubbish and little riparian vegetation. Laying the bits of hedge, removing the barbed wire fence and gap filling with native tree species will lower this hedge, thicken it and allow light to get to the ditch, allow better riparian habitat

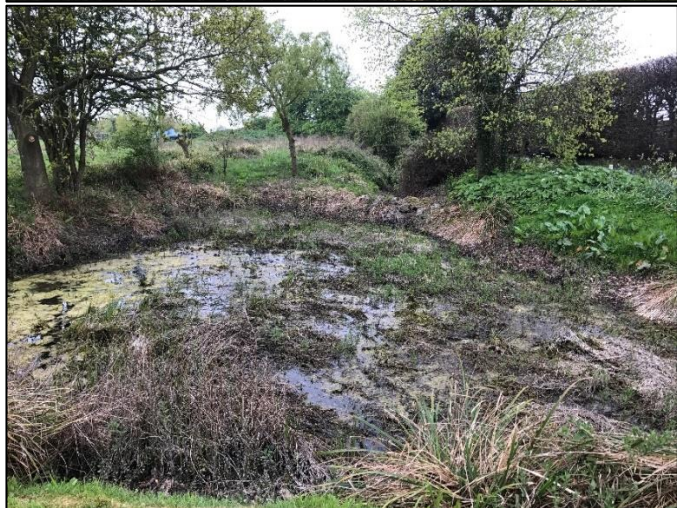
**Earnley Grange** - The pond contains lots of silt and vegetation. This allows the pond to dry out and increases the abundance of terrestrial vegetation. Digging it out would allow it to hold water for longer and to be attractive to wetland species
