Appendix iii: Example photos of findings

Potential drainage and environmental Improvements

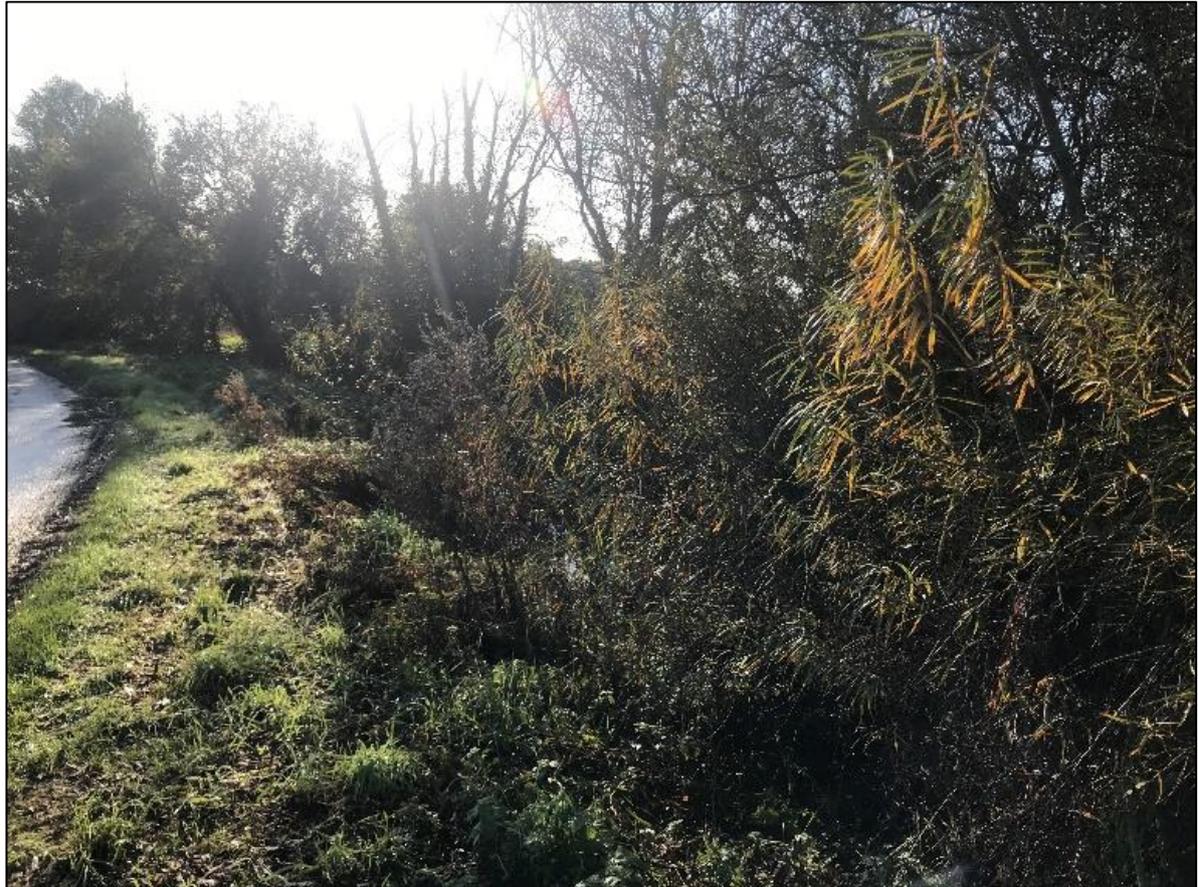
1. **Camic pond (SU 87972 00806)** – this relic farm pond dries out as it is full of silt and has not been managed in many years. It is a key part of the drainage system of South Mundham and increasing its capacity will benefit water management in the area during high rainfall events. Recent work has improved the tanking capacity, opened up the surface to the light and volunteers have planted trees.

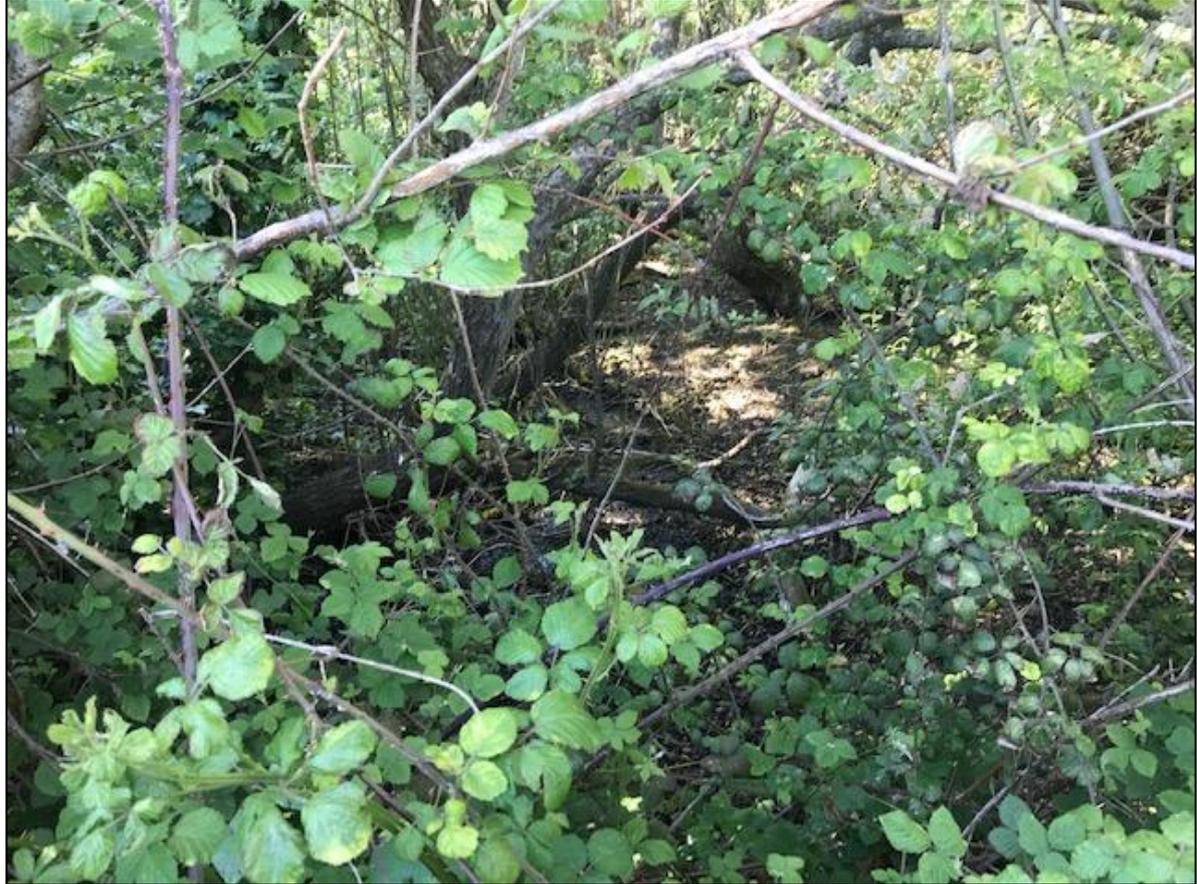
2. **Bowley Lane** (SU 88162 00304) - there is a deep pond on this 's' bend of Bowley Lane which has not been managed and is full of silt. Overhead power lines run across the pond so improvement work will have to bear these in mind. Willow trees grow over the pond shading it out and reducing biodiversity. Due to the local flooding issues in the area, increasing the tanking capacity of this pond would be of benefit.

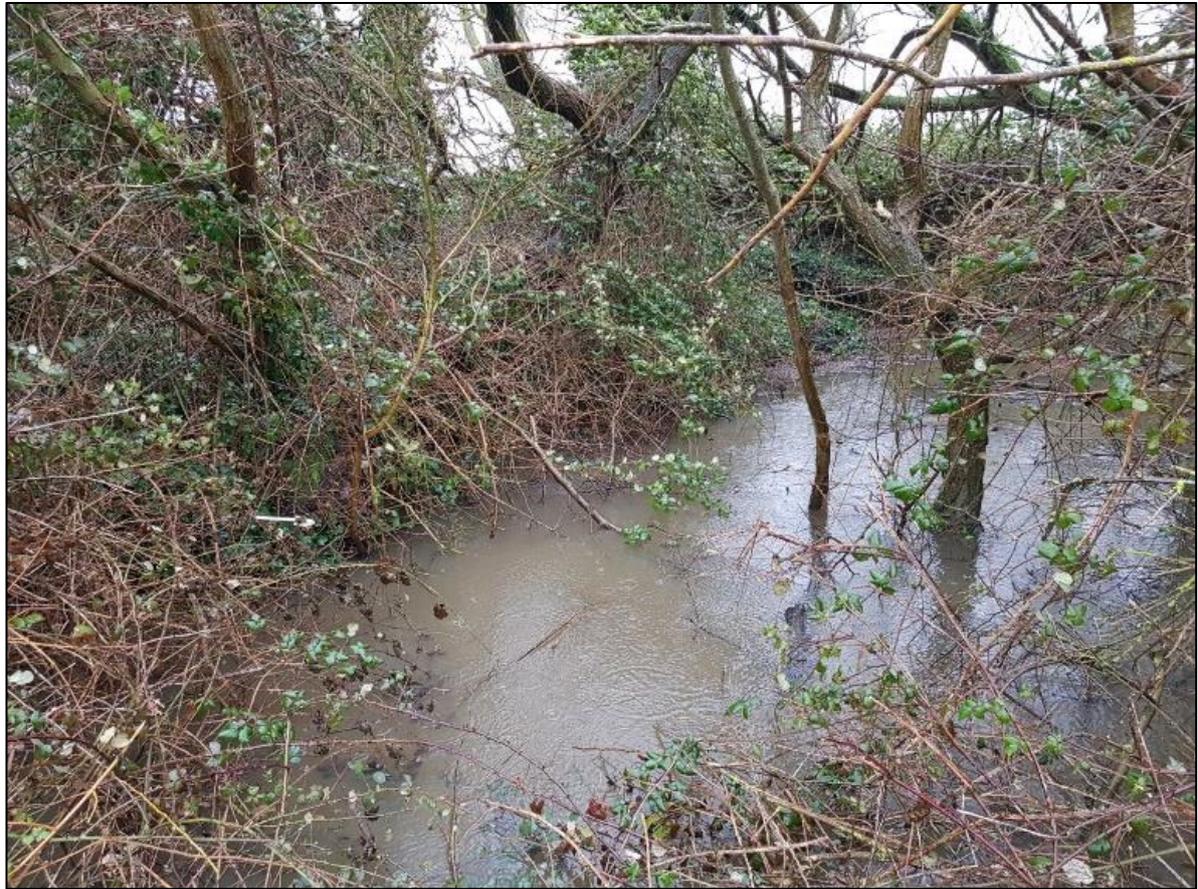
- 3. Honer Lane footpath (SU 87602 00276)** – this corner of Honer Lane has serious flooding issues and the ditch running parallel to the Honer lane is blocked. Honer Lane has a relic pond which dries out and digging it out will alleviate some of the flooding problems further down.

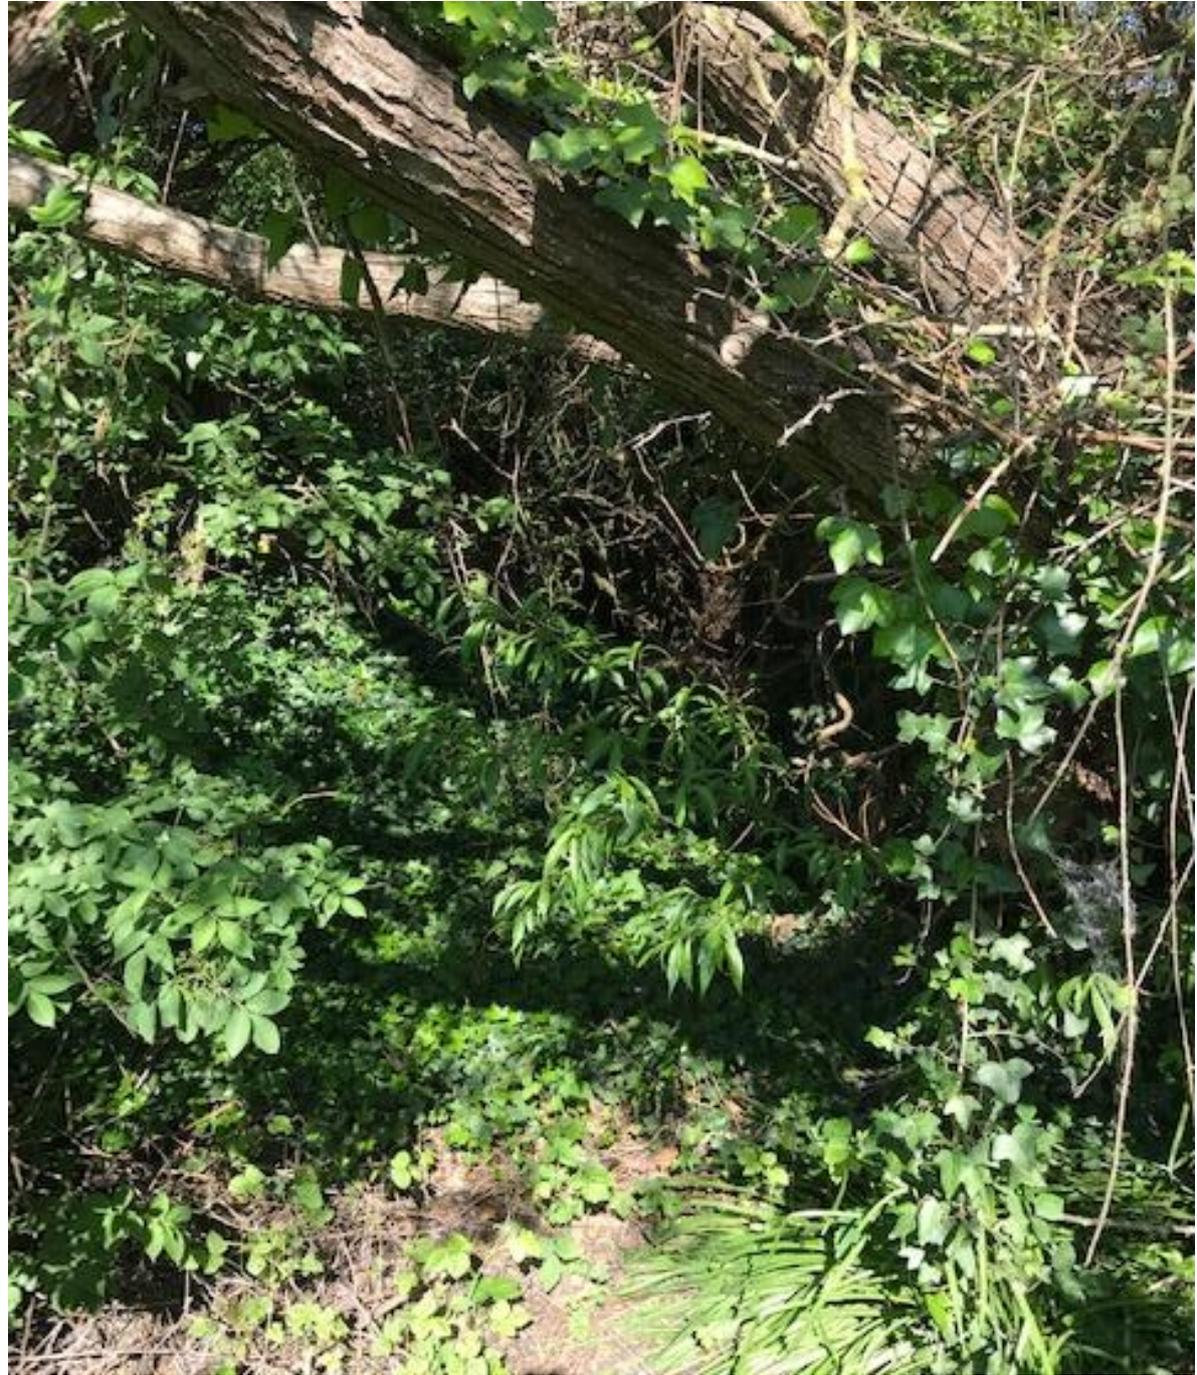
4. **Honer Lane / Pete's Farm pond (SU 87813 00091)** - this lane is prone to flooding due to discontinuous ditches and low-lying land. Two ditches join one ditch and there is a wildlife buffer strip containing hedges and wildflowers. Digging a tanking pond at this site will hold water, improve biodiversity, and support the existing habitat for bats.

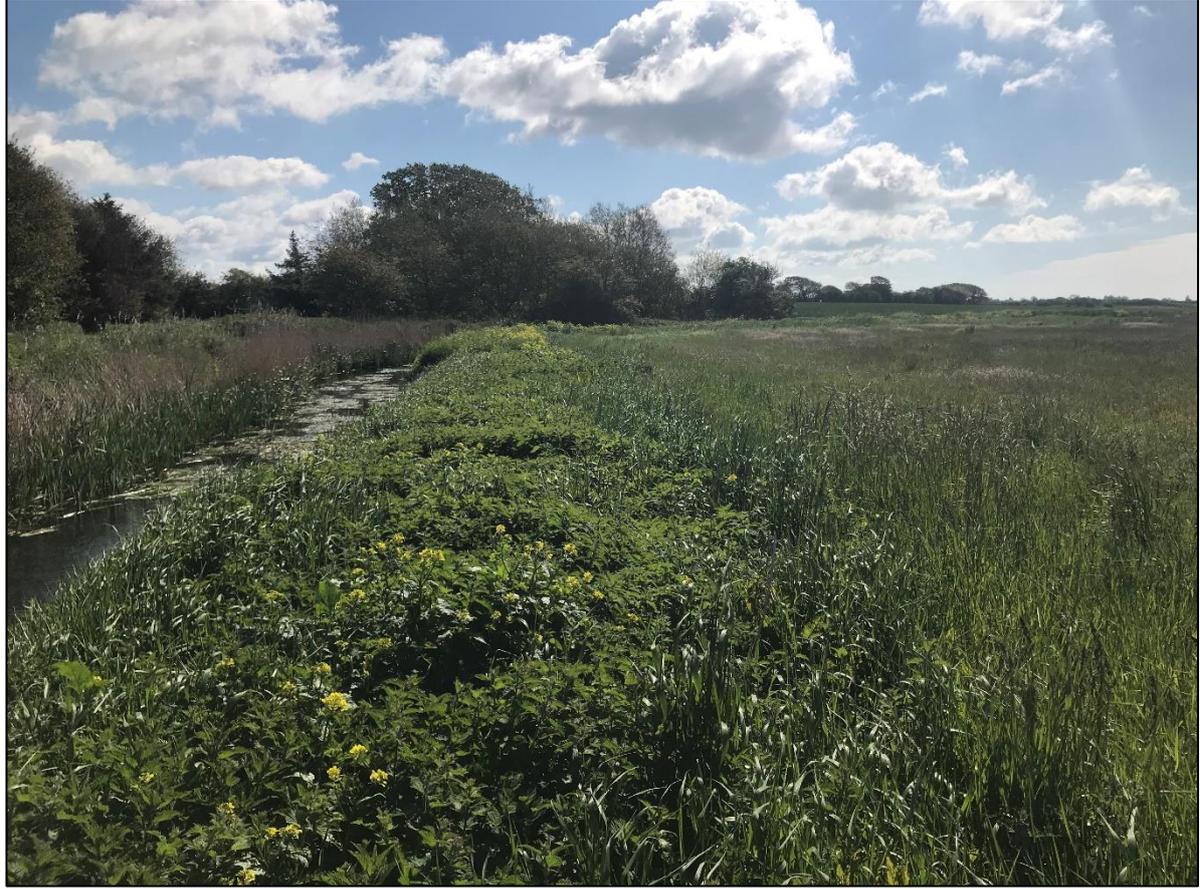
- 5. Pagham Rife Marsh (SU 88486 00715)** - situated on the Pagham Rife close to Camic Pond, this low-lying wet meadow contains water during the winter and supports bird species like Lapwing. Digging deep areas, creating spoil mounds and permanently wet meadows will improve biodiversity for more species. Moreover, planting new hedgerows and mini woodlands will reduce flooding in the local area.

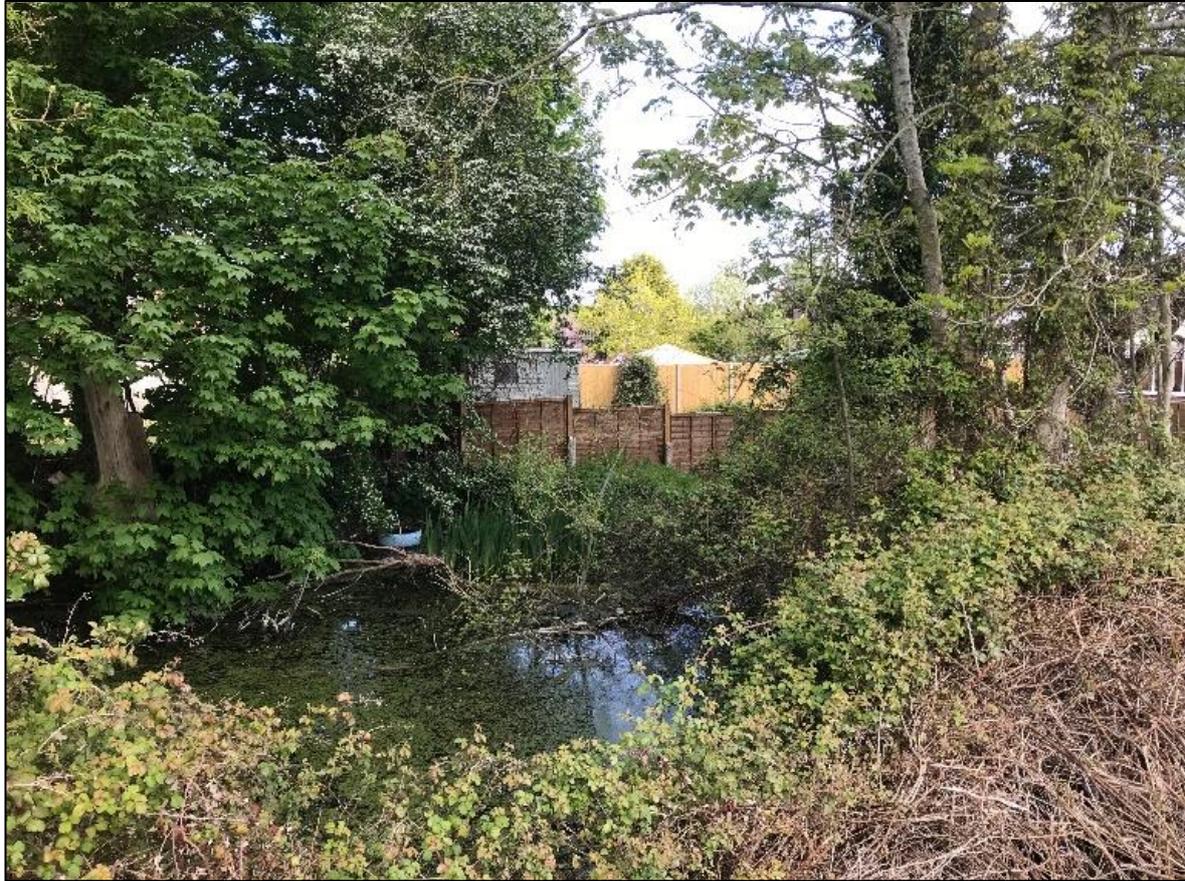
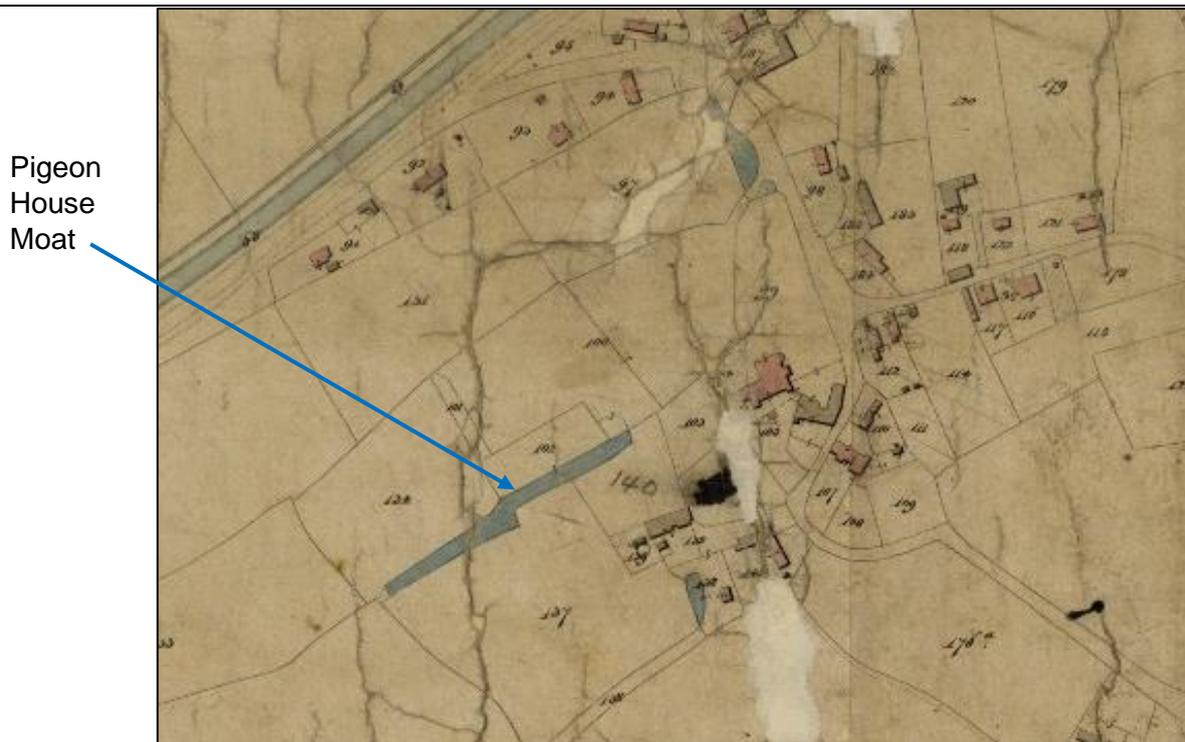
- 6. Pigeon House Moat (SU 87320 02187) -** this section of relic moat dries out and is full of silt and rubbish. It still currently supports bats, moths, butterflies, and frogs but digging this area out and managing the surrounding trees to get light in on the water surface will improve species diversity.

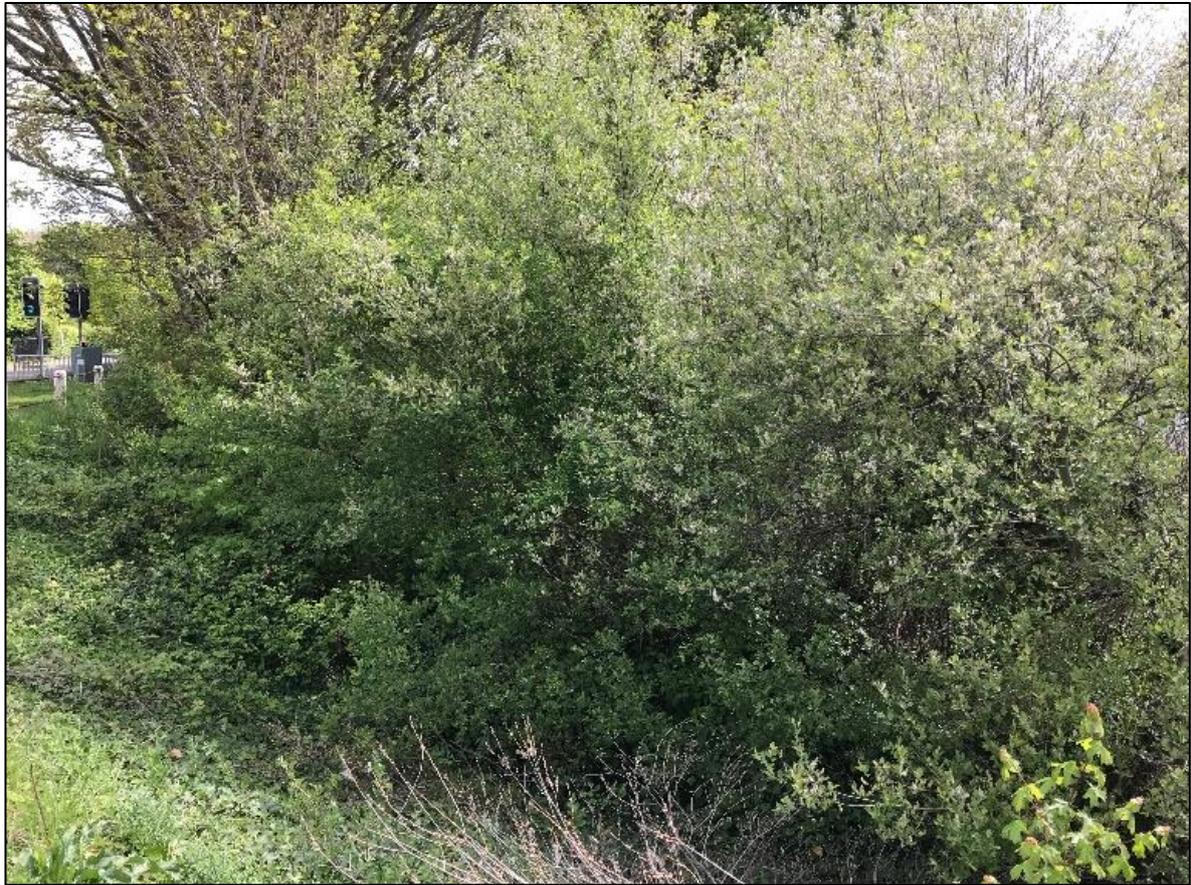
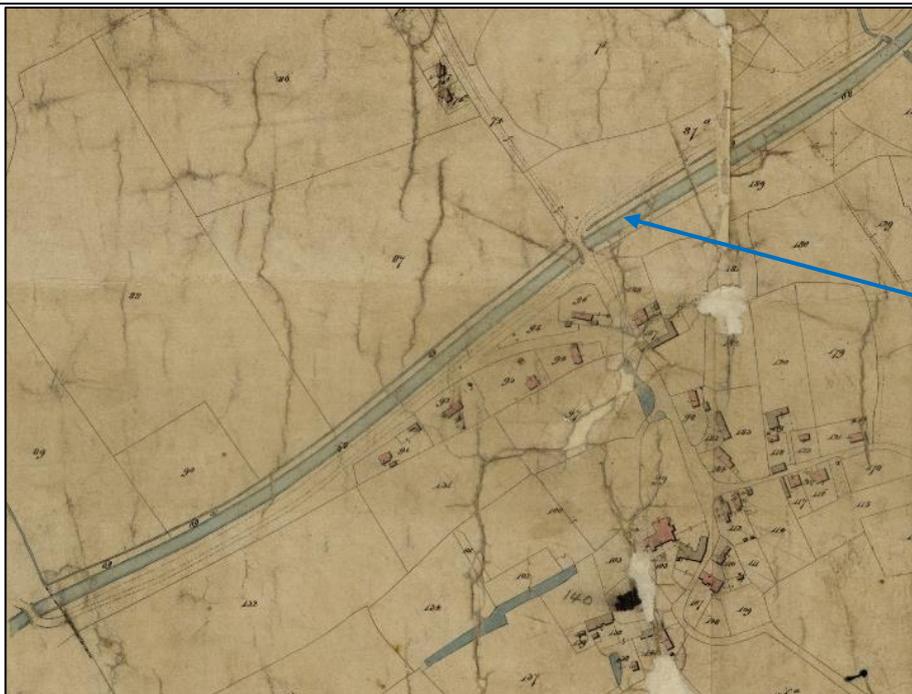
- 7. Arundel to Portsmouth relic canal (SU 87641 02409) - undermanaged for many years this stretch of the relic canal has a large accumulation of silt and rubbish. Opening up the waterway, digging it out and putting in a dead hedge will improve the habitat opportunities for many species.**

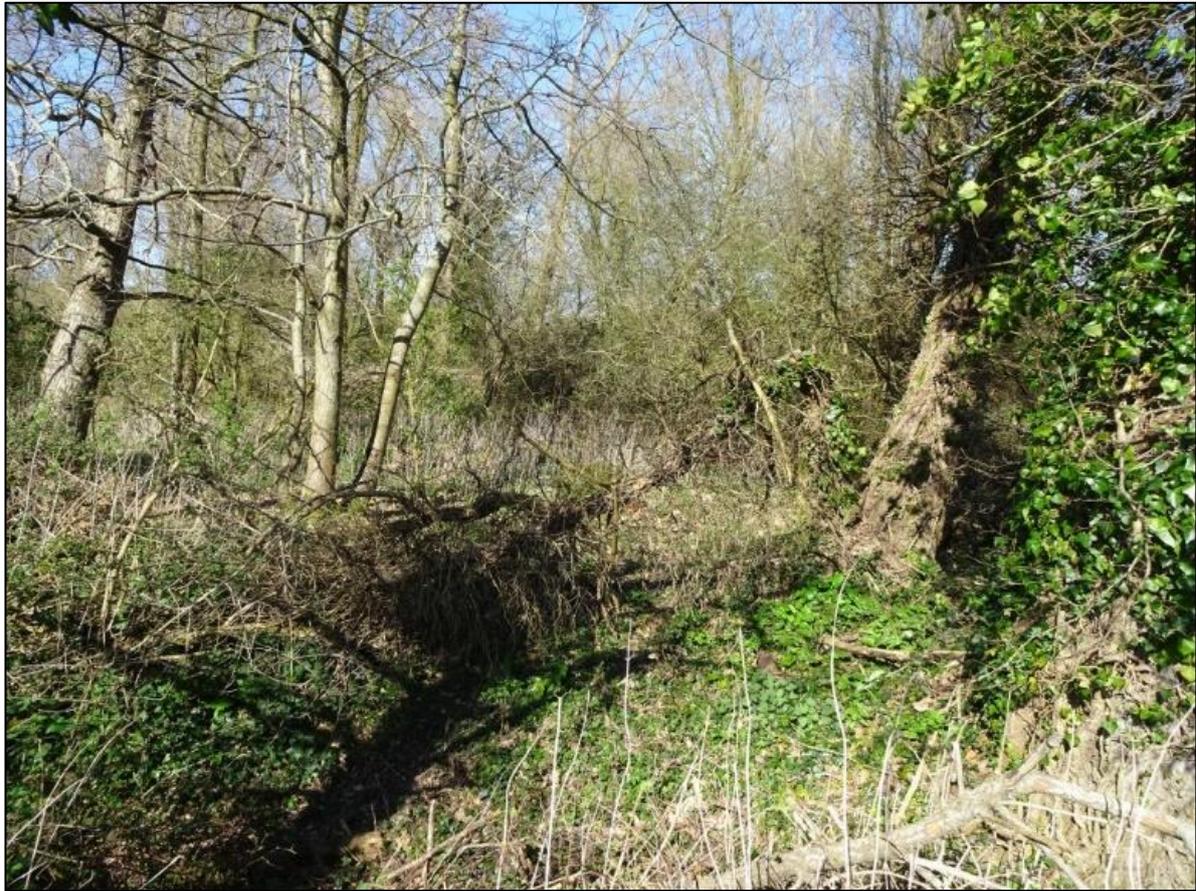
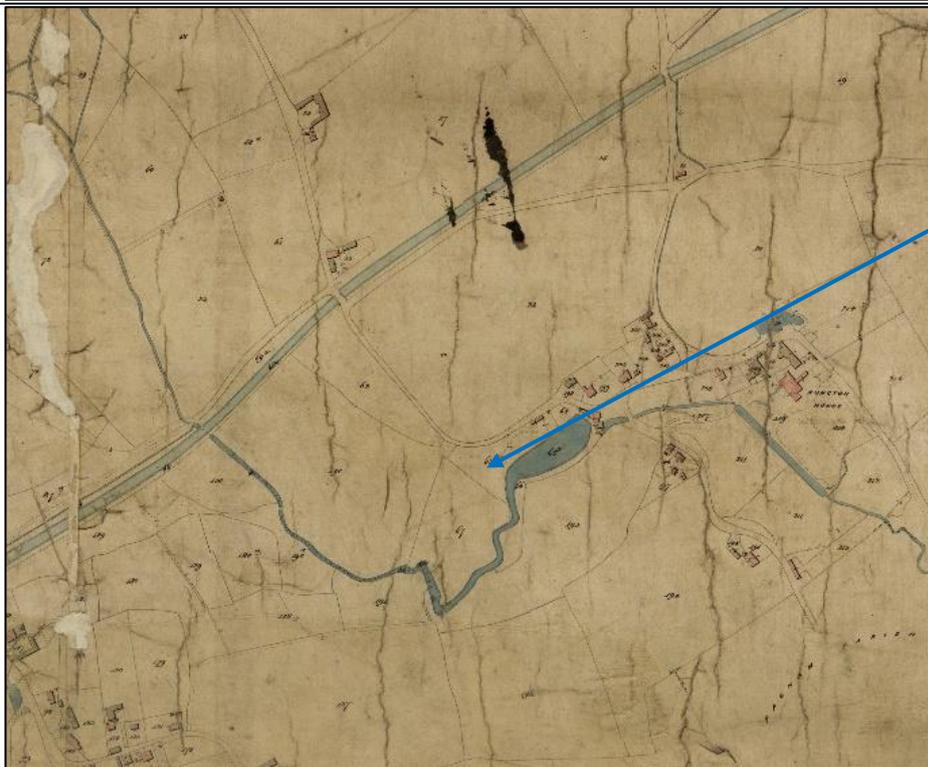
8. Runcton Mill wetland (SU 88156 02217) - this site has a large wet woodland bordering Pagham rife. A dried-out ditch runs through the middle but digging this out will improve a corridor for water voles and other species. It will also hold more water during high rainfall events.

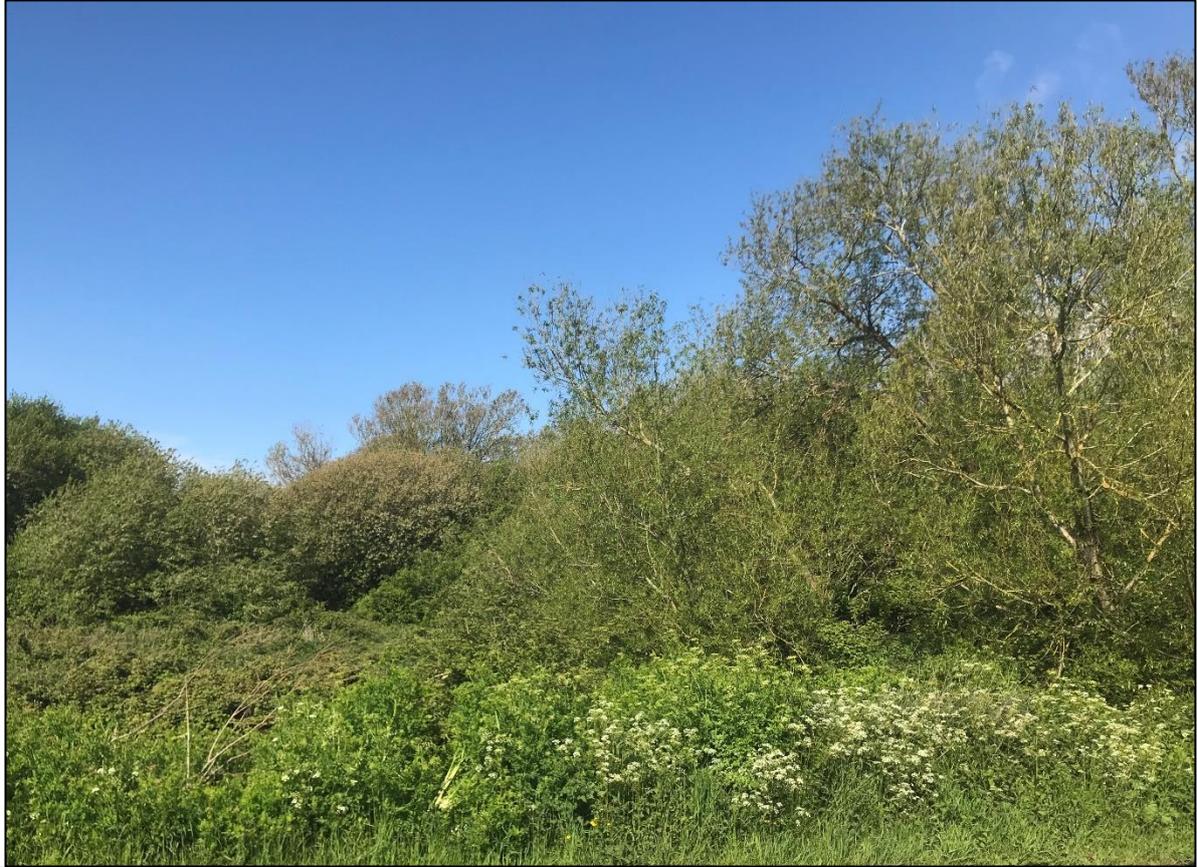
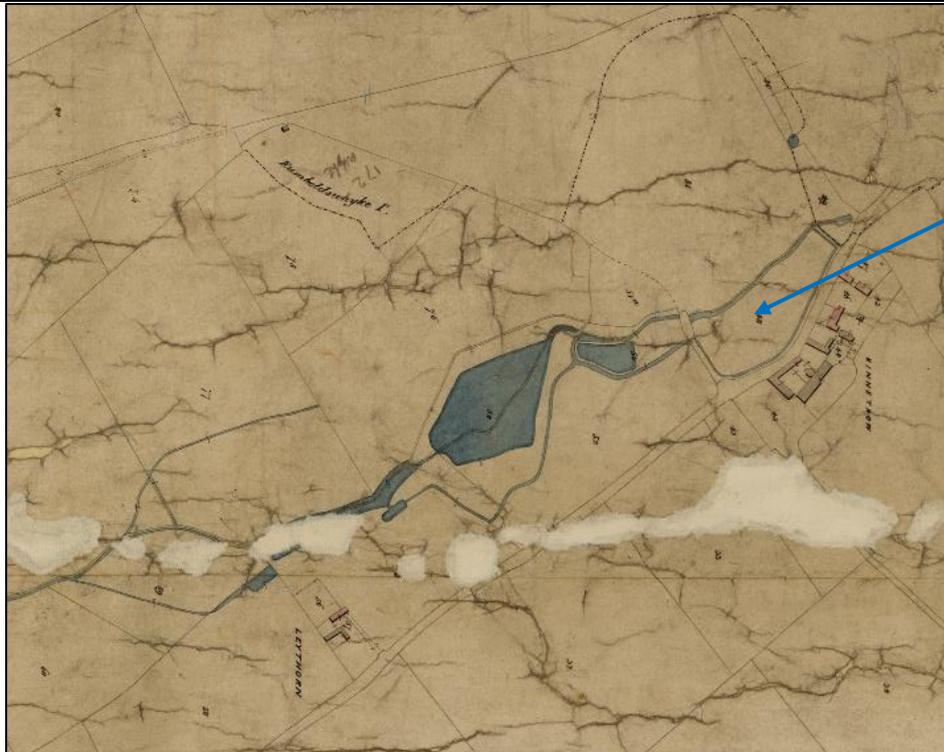
9. Vinnetrow Road wetland (SU 88036 03385) - this is an overgrown Willow copse, adjacent to SWT trust owned Leythorne meadow, with the only chalk stream on the MP. This site has a deep silt layer and it would be beneficial to dig out some pond

areas. Reinstating this wetland's natural features - ponds, scrub, wet meadow, and high banks will greatly improve the biodiversity opportunities.
