Appendix iv: Photos and sections of the Donnington Parish 1839 tithe map of the sites for potential improvement

Donnington ditch condition assessment results and habitat improvement plan

Appendix iv: Photos of potential improvement opportunities
Fixing and Linking Our Wetlands

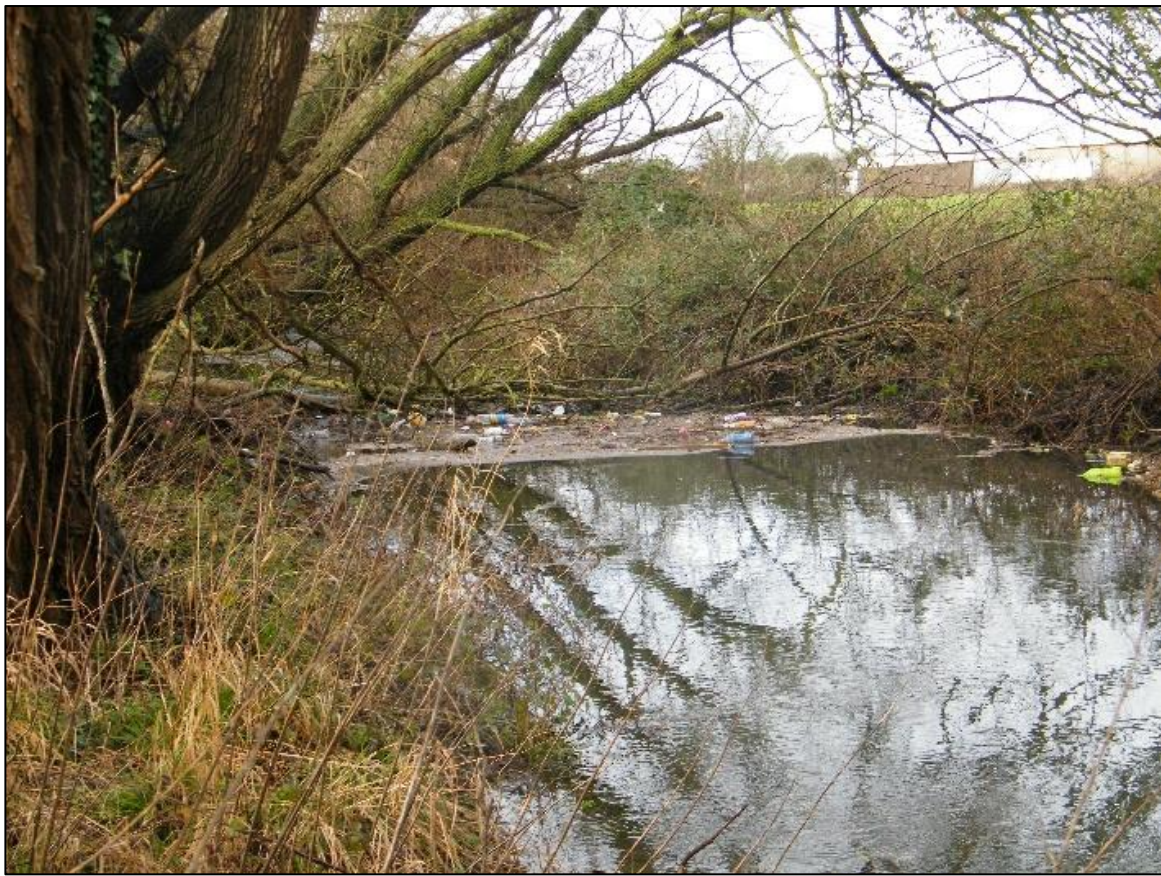
- 1. River Lavant (SU 85277 04028)** - this section of river is full of litter and needs to be regularly cleaned out to prevent pollution and the plastic and other waste making its way into Chichester Harbour.

There are many fallen trees and branches that are tented in bramble and are heavily shading some sections – these could be cleared away, the dead wood stacked on the banks and a better range of habitat opportunities created.

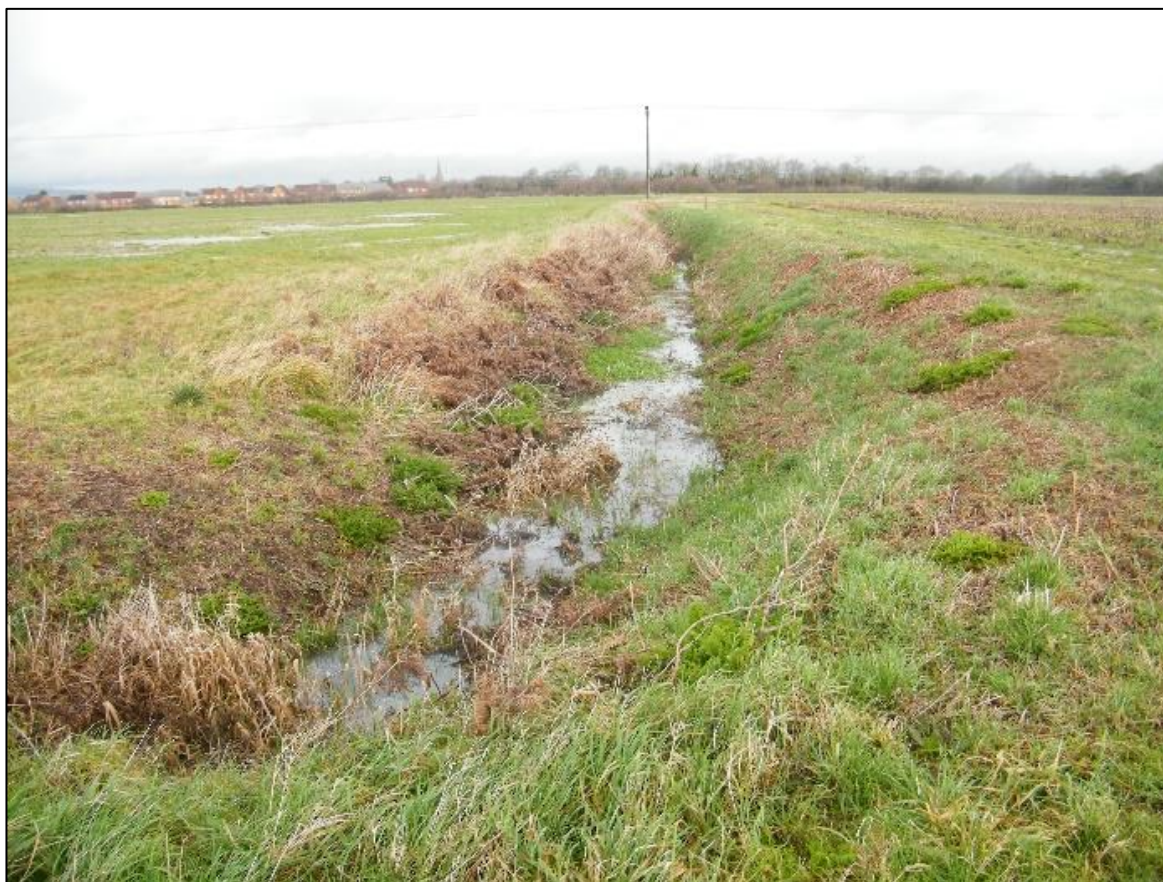
2. **Donnington Manor Farm** (SU 8593 702656) - where Dingles, Poor Field and Twenty Five's field meet there is the potential for digging out a deeper area to create junction pond to hold water for longer and improve capacity. This would provide a greater area for water to be held during high rainfall events while also creating good wetland habitat for wildlife.
A hedge could also be planted along one side of the ditch to help soak up water, preserve the soil and cut down on wind erosion.

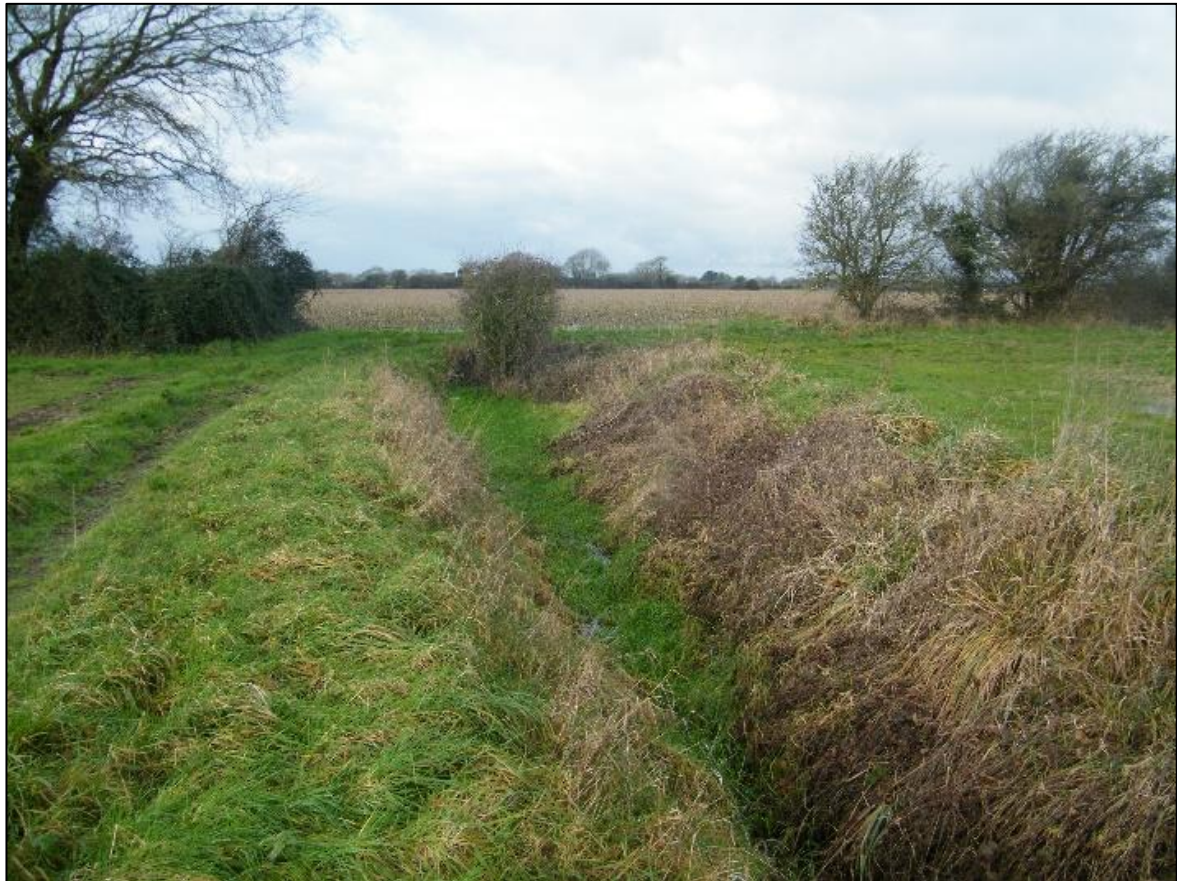
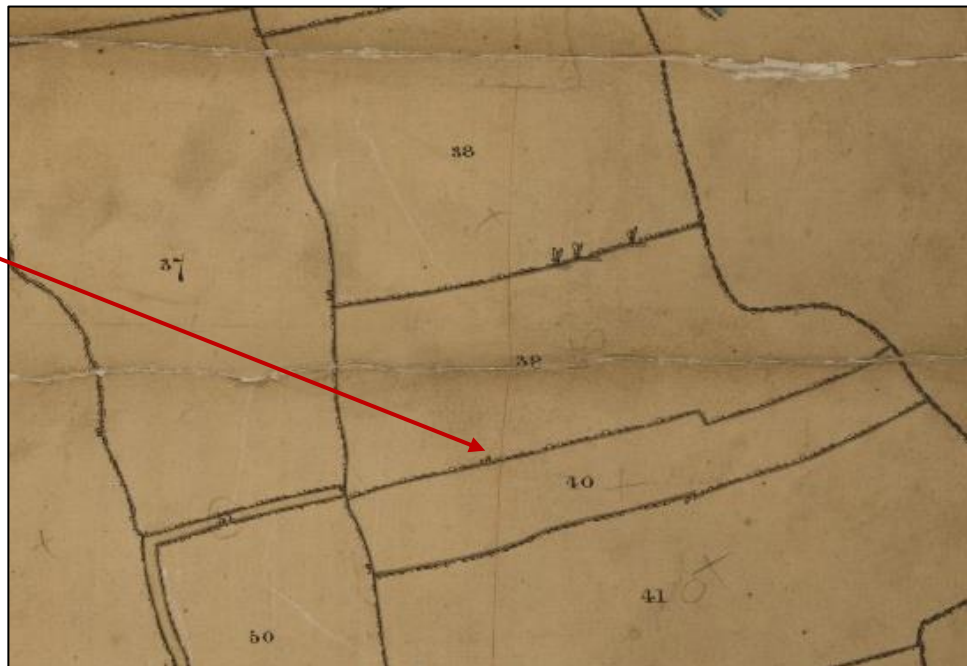
- 3. Donnington Manor Farm (SU 86150 02458) - tramlines north and south fields off Selsey Tramway – there is potential to dig out and reinstate a relic pond that appears on the 1839 tithe map for the parish, at the western end where ditch widens out and deepens. This will increase the tanking capacity for holding water and improve the quality of the wetland habitat.**
A hedgerow could also be planted to one side to reduce soil erosion and to link up the wildlife corridors.

Deep wide section of ditch / pond seen on old tramline site

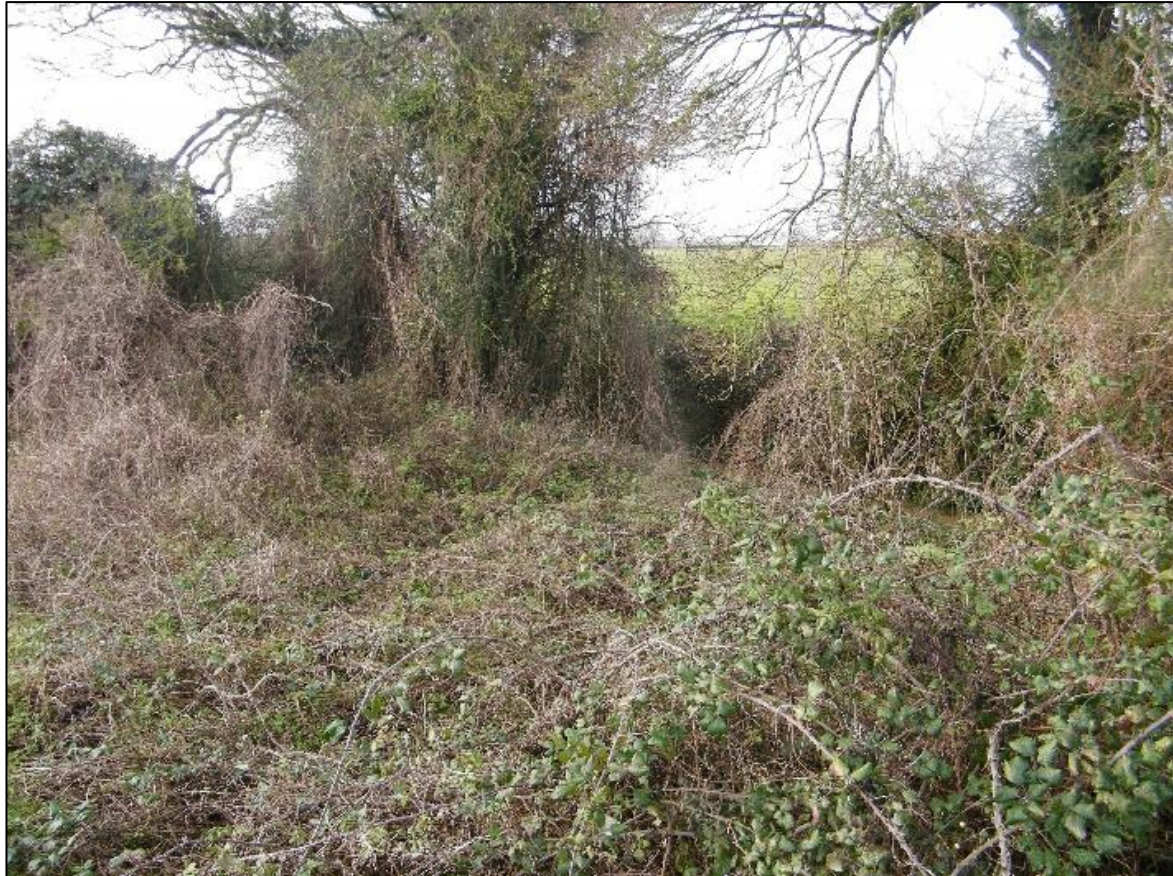
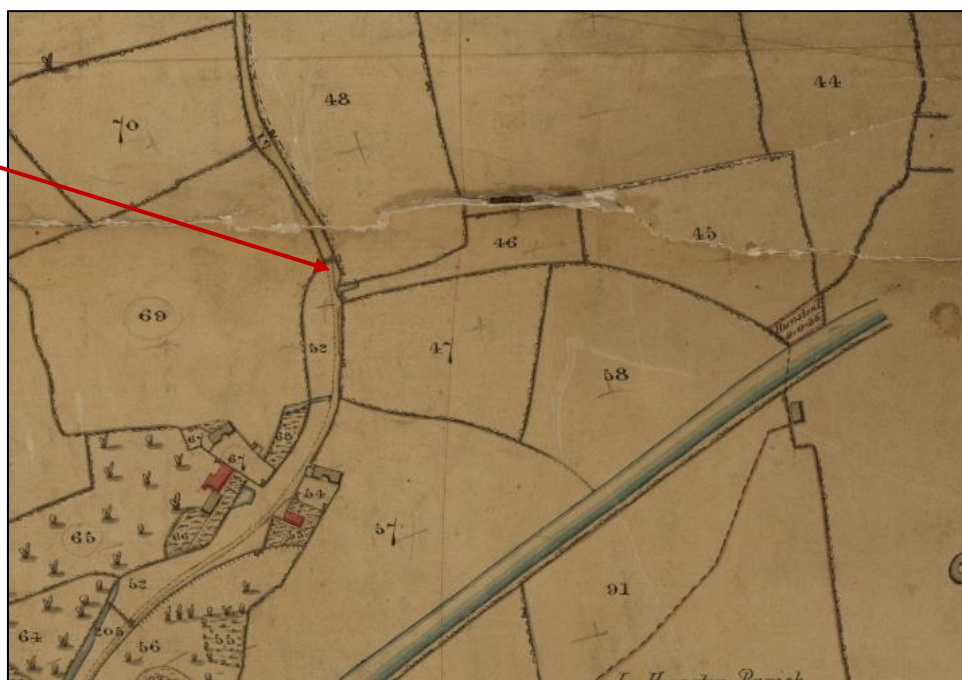
4. **Donnington Manor Farm (SU 85811 02525)** - the old roman road ditch at the end of Pelly's Lane is the site of a large relic pond that appears on the 1839 tithe map for the parish and could be dug out and opened up by removing some of the surrounding trees and scrub. This would create an area for more water storage and wetland habitat for wildlife that would link with the surrounding ditches. The water may stay in this pond for longer while the surrounds waterways dry up, giving it extra habitat value.

Relic pond
seen next
to roman
road

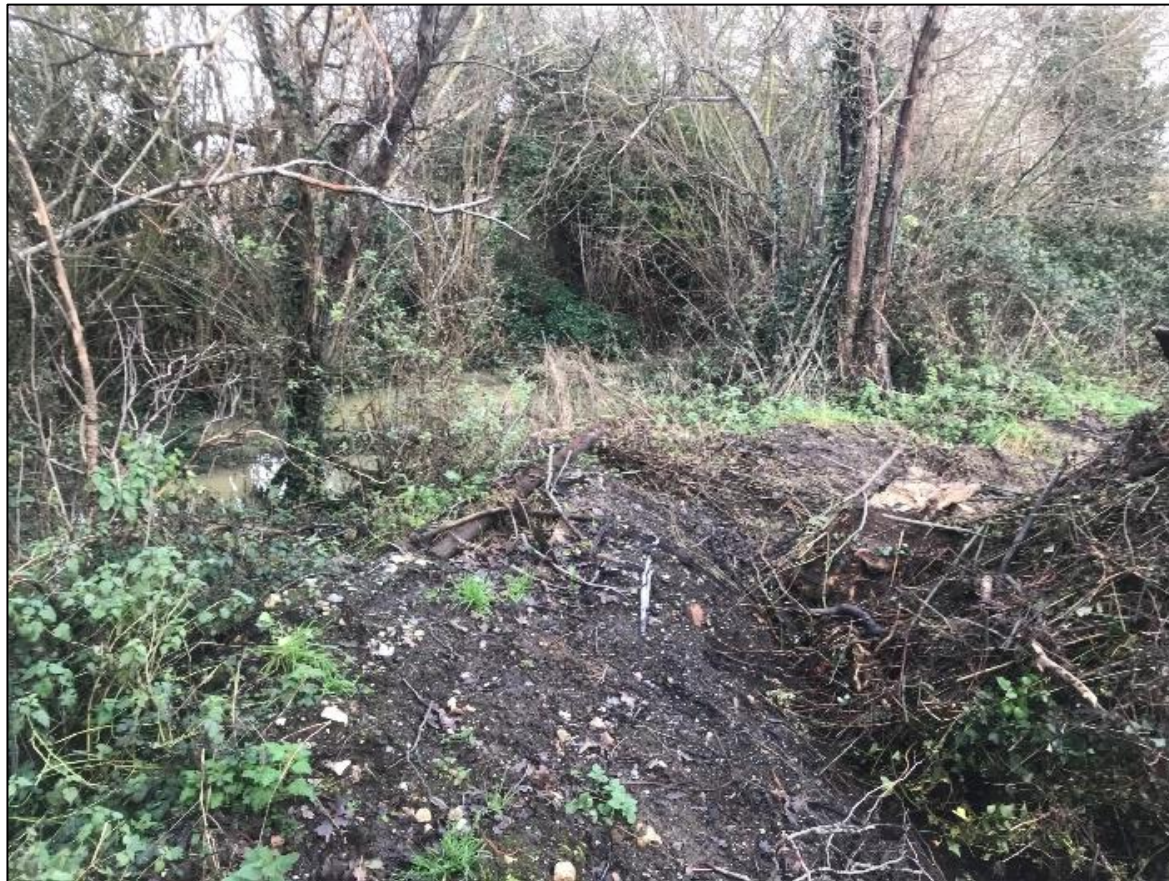
5. **Donnington Manor Farm** (SU 85767 02259) - the old the roman road site – there is evidence of long-term rubbish burning and dumping here and it is close to the waterway and has the potential to pollute and over-nutrient the water. This could be removed and the area re-planted.

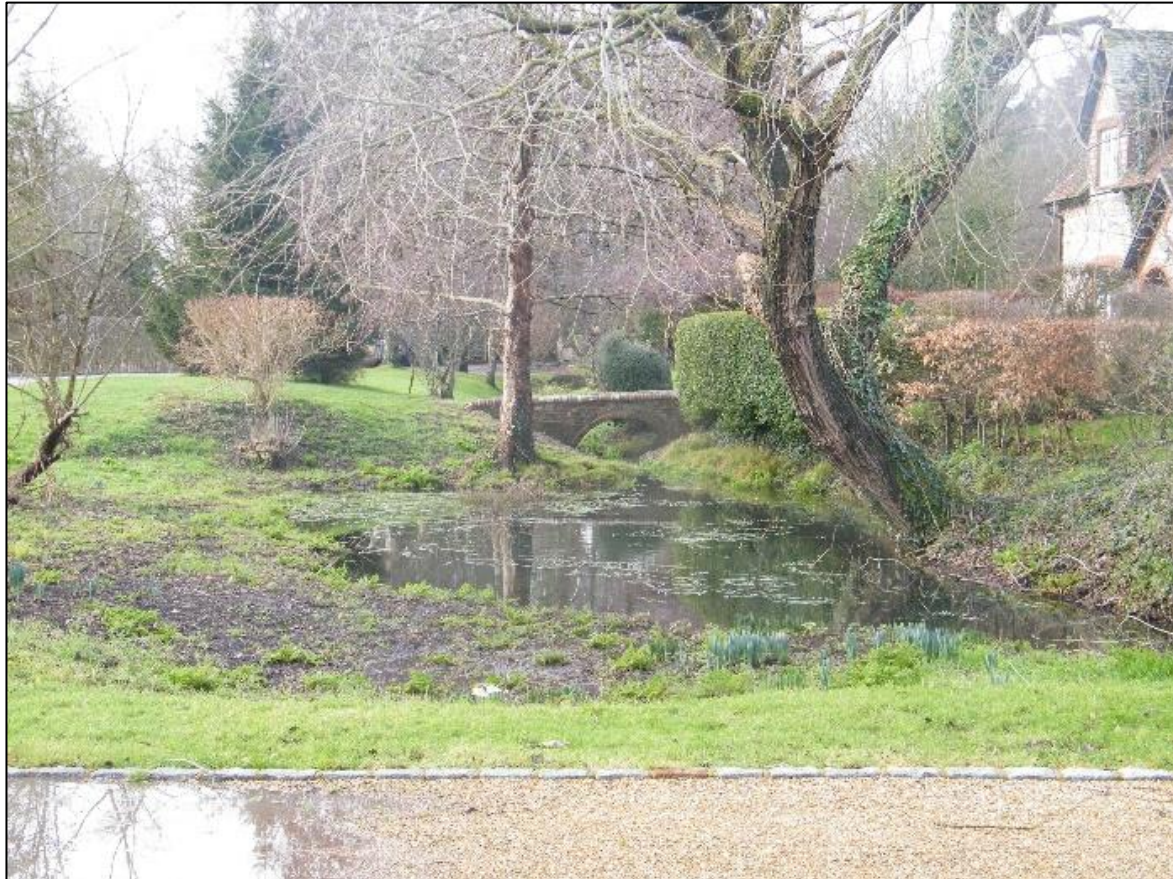
6. **Pelleys Lane pond (SU 85686 02162)** - there is potential for deepening this pond, that appears on the 1839 tithe map for the parish and linking it to the wider ditch system. This would add value to the wetland habitat network and may result in the site staying wetter for longer

Pelleys
Lane pond

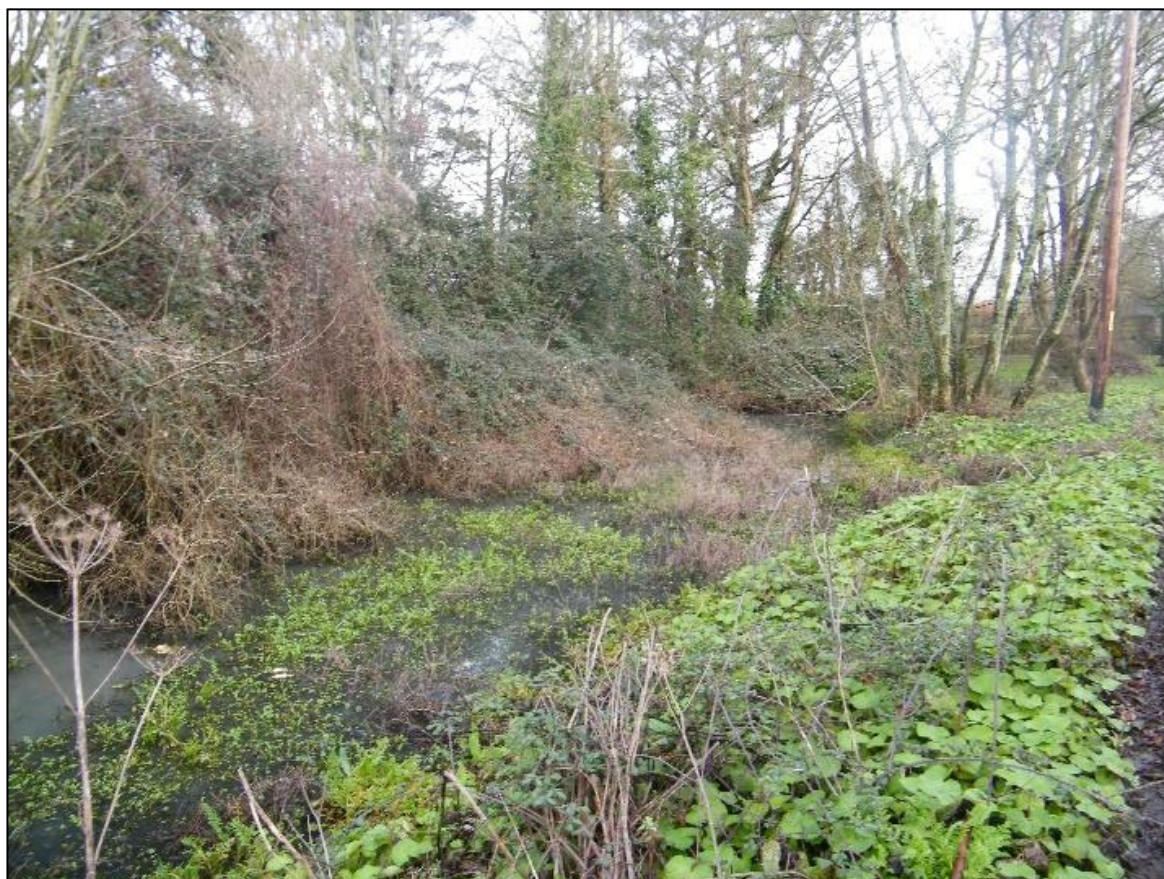
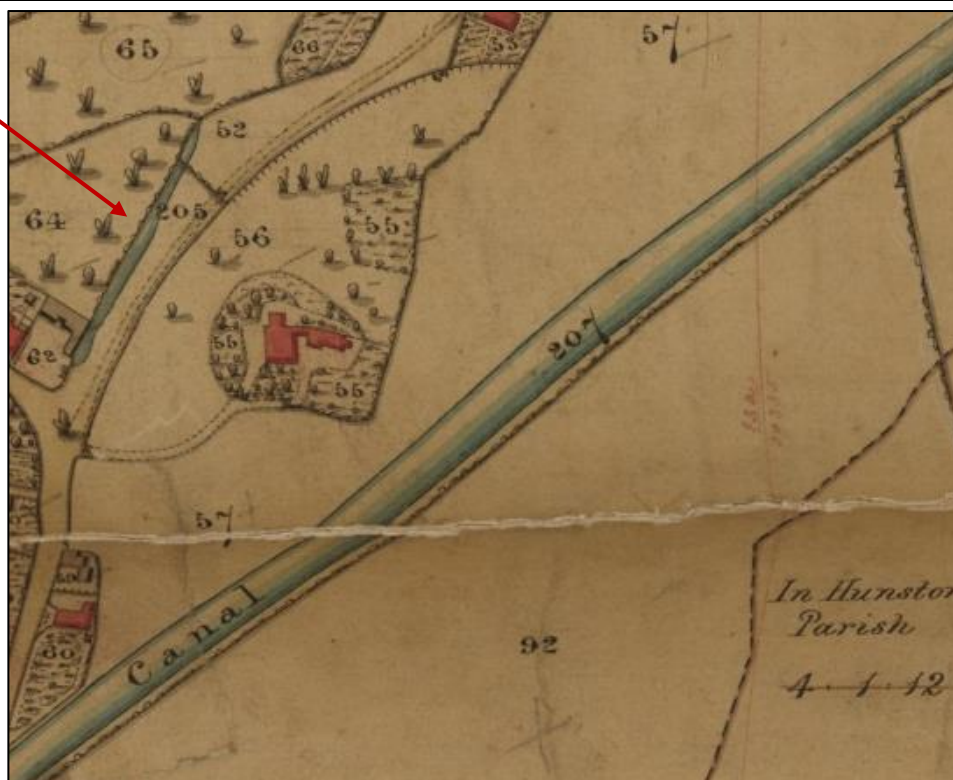
7. **Pelleys Lane ditch** (SU 85552 02106) - this ditch is wide and full of riparian vegetation but by managing the shading trees and bramble a greater range of biodiversity could be achieved. A section would benefit from being dug out to keep it wet for longer and therefore offering valuable refuge for wildlife during the summer when many ditches dry out.

Pelleys Lane ditch

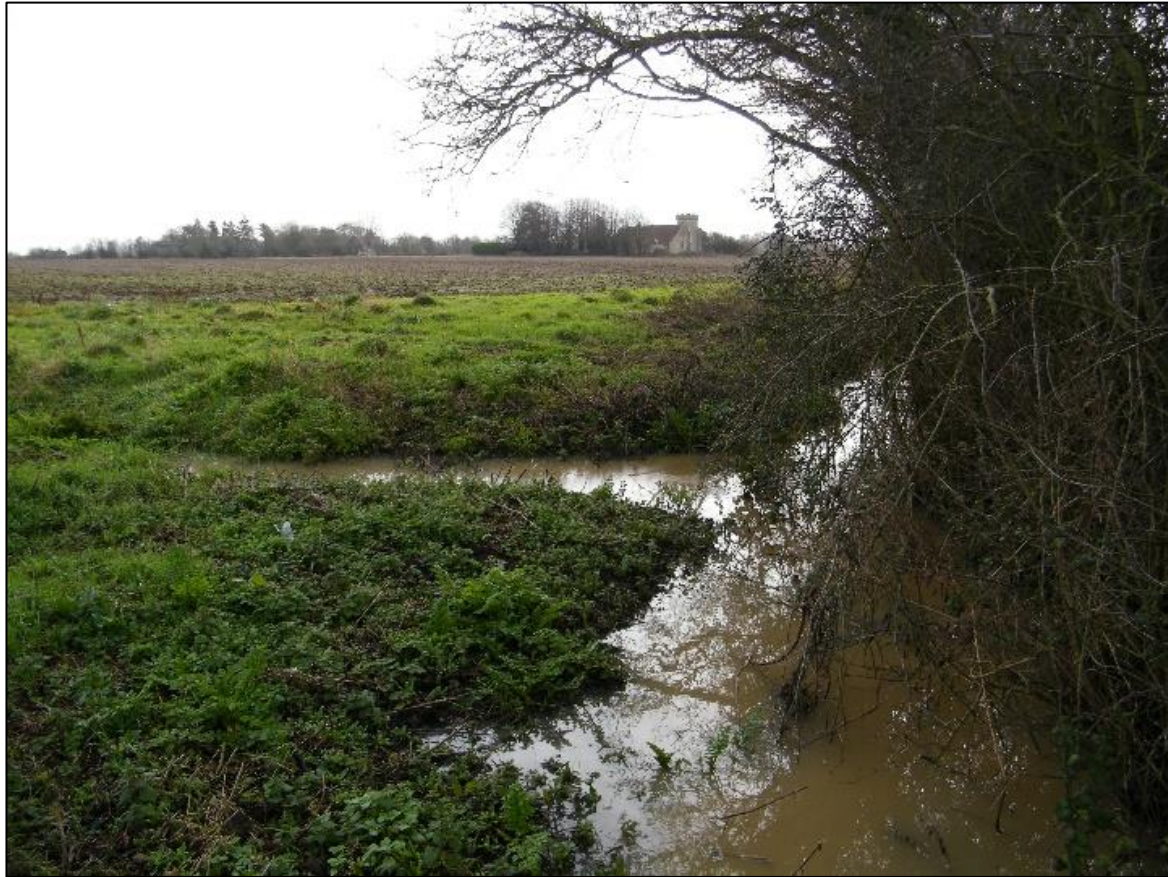
8. **Donnington Manor Farm** (SU 85106 02454) - ditch junction south west of Donnington Manor. There is potential for a junction pond at the western end where main ditch turns to the south. This would create an area for holding more water for longer and add value to the wetland habitat.

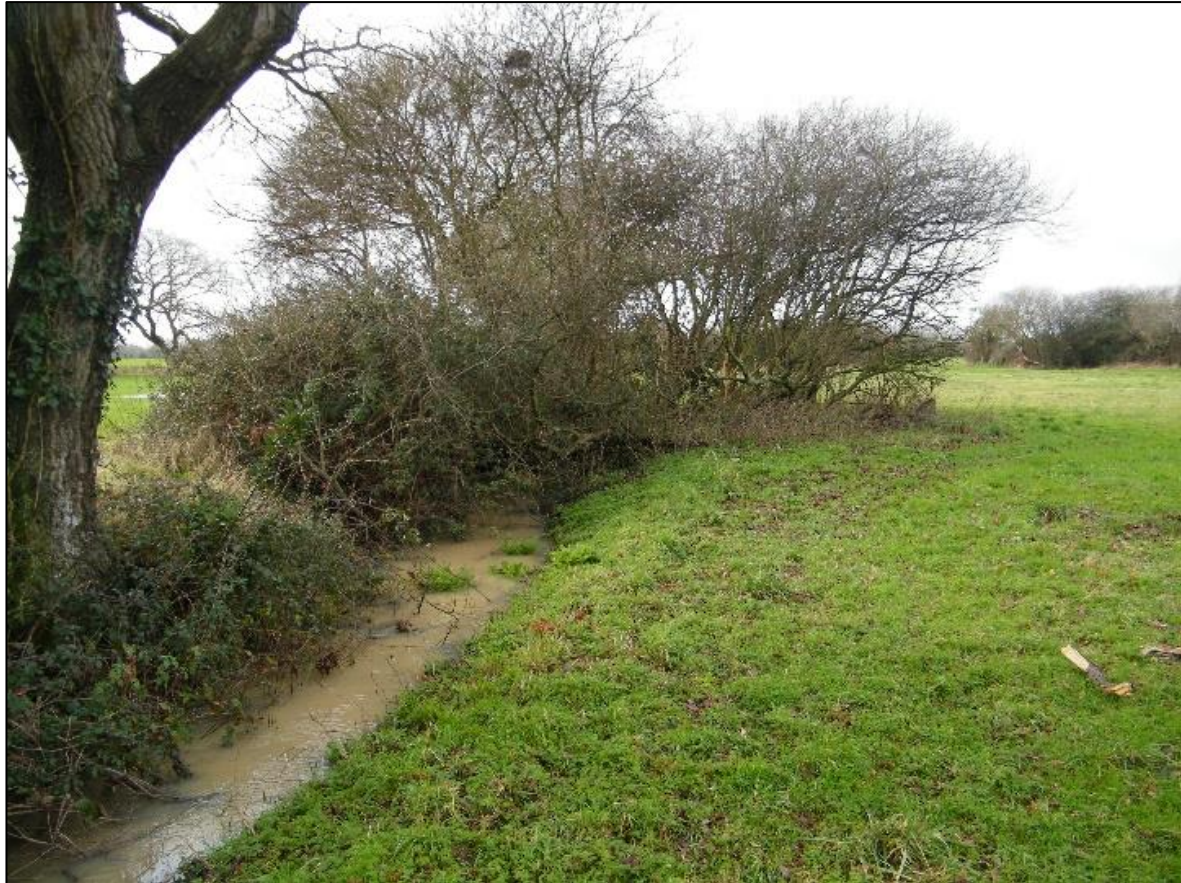
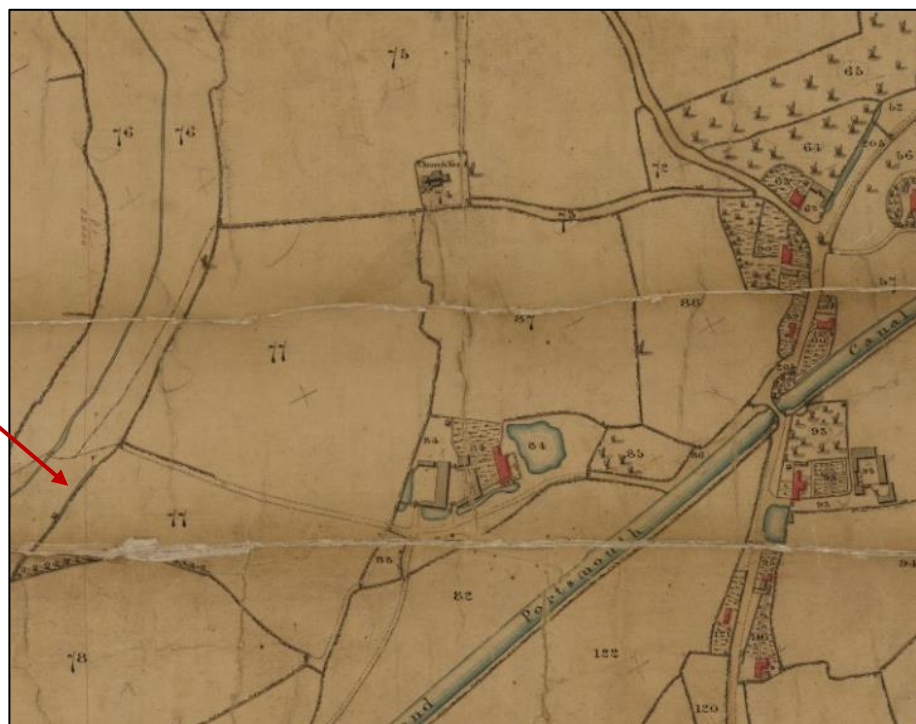
- 9. Donnington Manor Farm (SU 84889 02116) - valley to west of Donnington church.** This natural valley has a mini floodplain and wet meadows either side and so is valuable to wildlife. There is a relic pond, that appears on the 1839 tithe map for the parish adjacent to this waterway but overgrown with willow that could be cleared and dug out. There is potential for tree planting in the hedge south of the footpath nearby would add connectivity.

Relic pond just on the edge of the Donnington rife flood plain

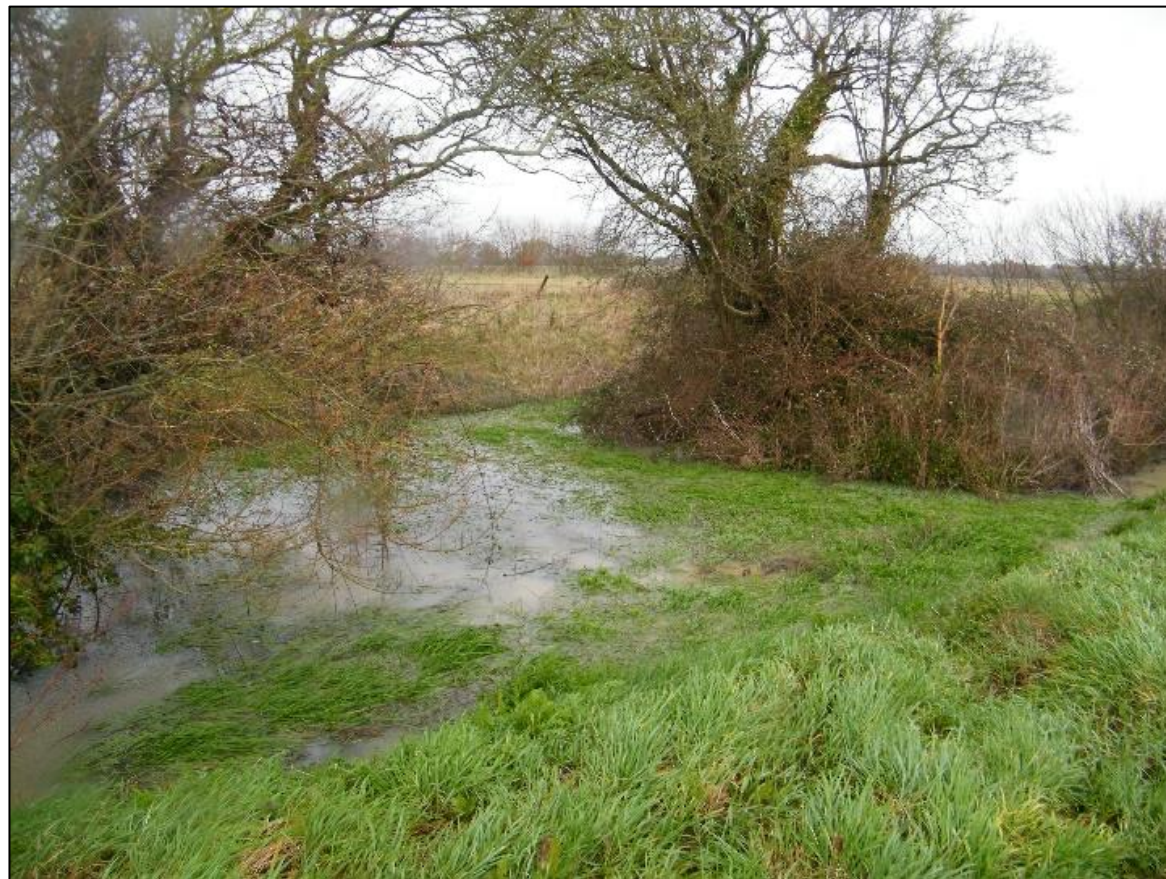
- 10. Southend Farm (SU 85573 01740)** - this relatively recently created pond on southern boundary of dairy field needs to have the vegetation managed to ensure the willow and bramble does not take over and it remains suitable for water voles. The size could also be increased to create more habitat and to hold more water for longer.

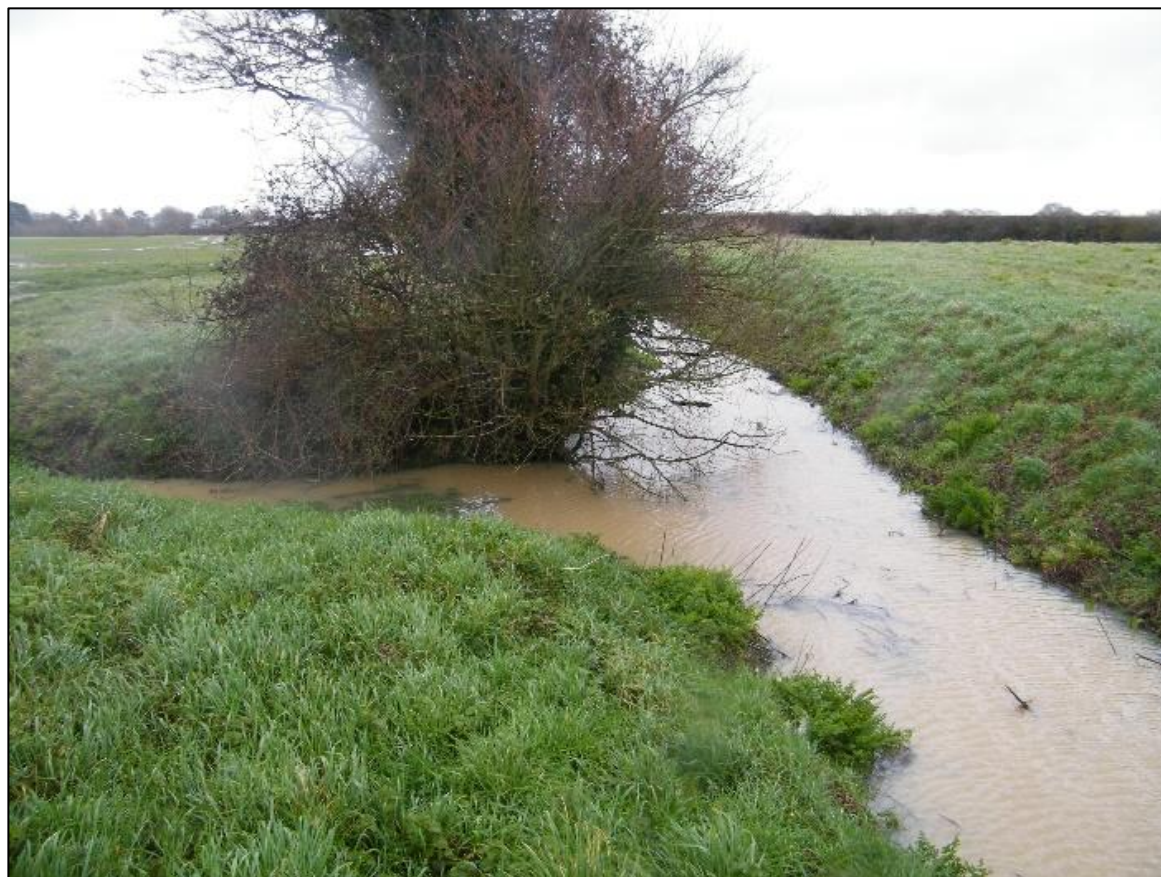
11. Southend Farm (SU 85063 01487) - this ditch junction south of the Blacksmiths pub has potential for digging out and deepening at this intersection of ditches to improve biodiversity and to hold water for longer.

A hedgerow could also be planted along one side of the ditch to prevent soil erosion, improve soil permeability, and add biodiversity value.

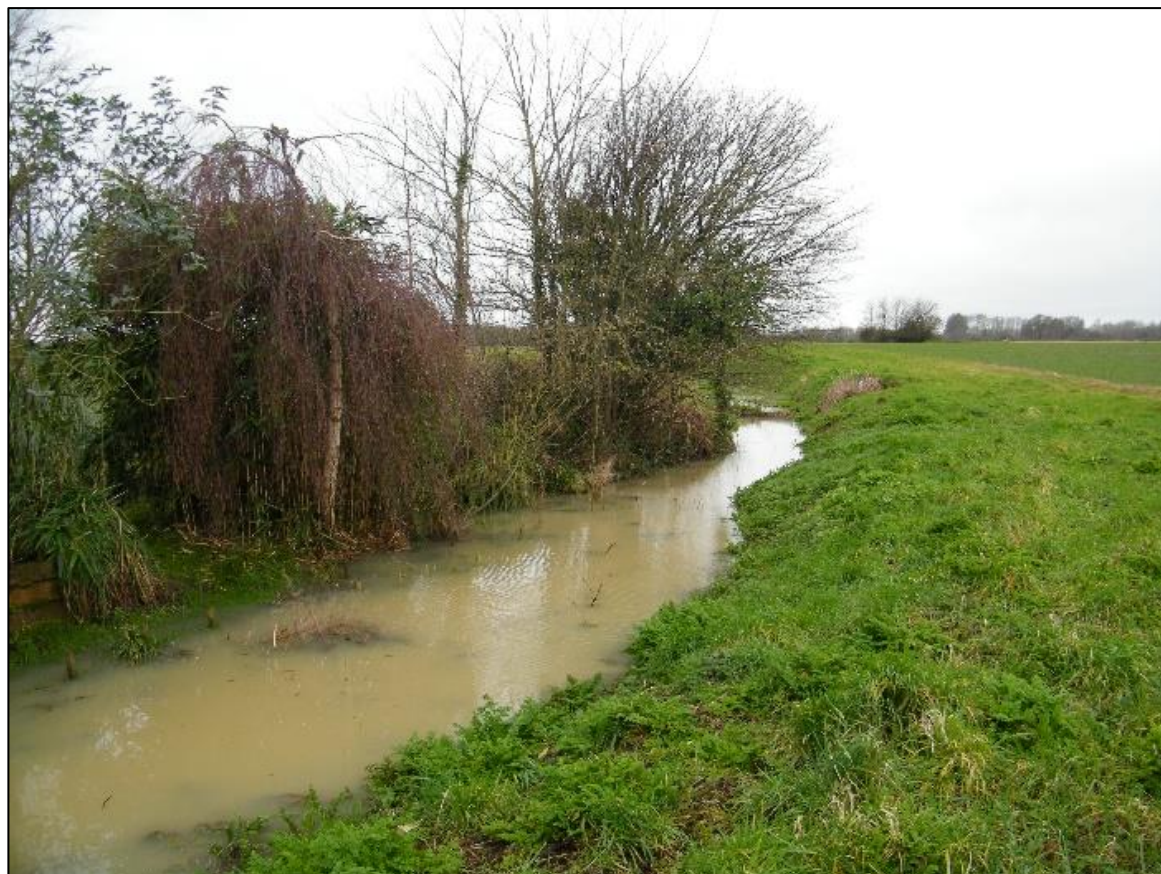
- 12. Southend Farm (SU 84957 01190)** - just adjacent to the B2201, south of the Blacksmiths pub, and next to a dwelling there is an opportunity to dig out a wide section of ditch that terminates here and which appears on the 1839 tithe map for the parish. This could create a wet area for longer and add wildlife value. A hedgerow could be planted to connect up the wildlife corridors and to improve biodiversity.

Relic pond along the property line and field boundary

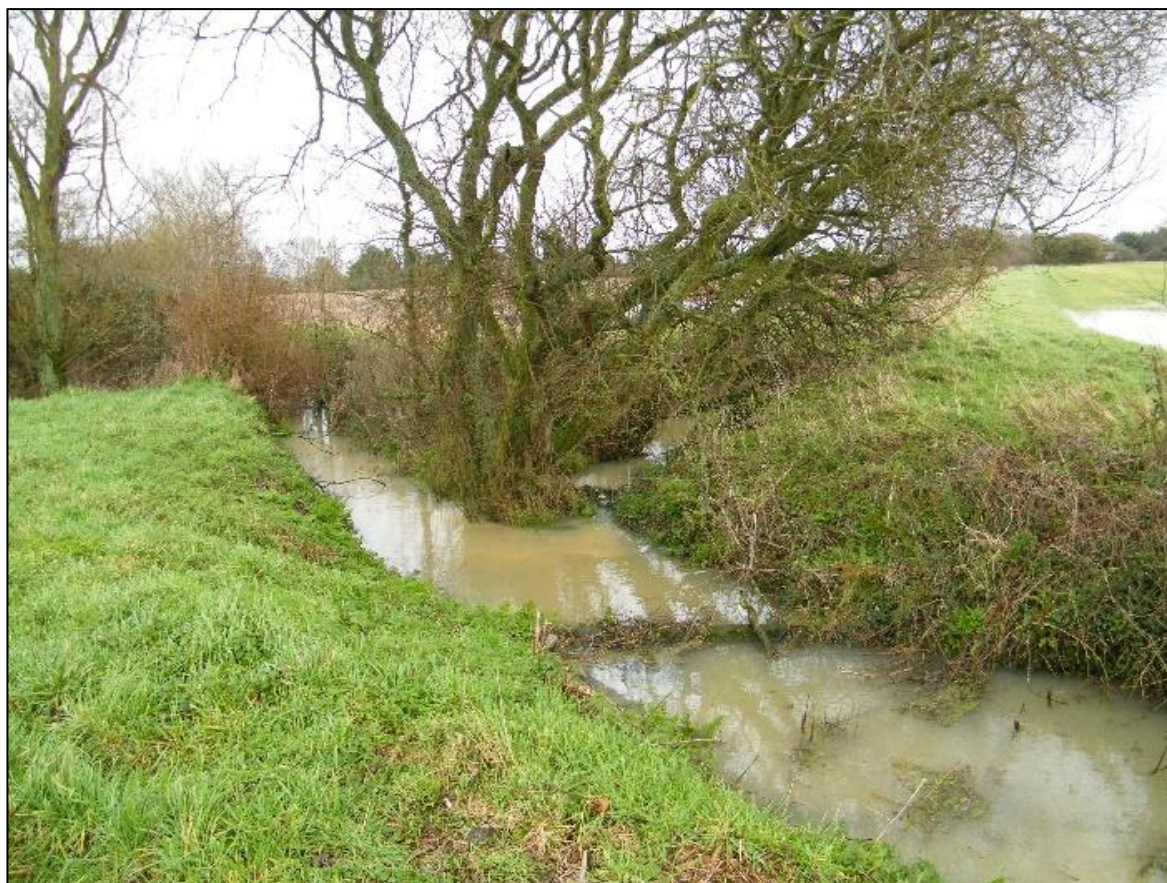
- 13. Southend Farm (SU 85271 01096) - Corners, Cooper and Peartree field junction.** There is an opportunity to dig out this area as a deep junction pond as it is the location where 4 ditches come together. This area appears on the 1839 tithe map for the parish as 2 ponds. Creating a deep large pond would offer refuge for wetland wildlife during the summer months when the surrounding ditches dry out and additional tree planting would re-enforce the wildlife corridor.

Two relic ponds at a 4-way ditch junction

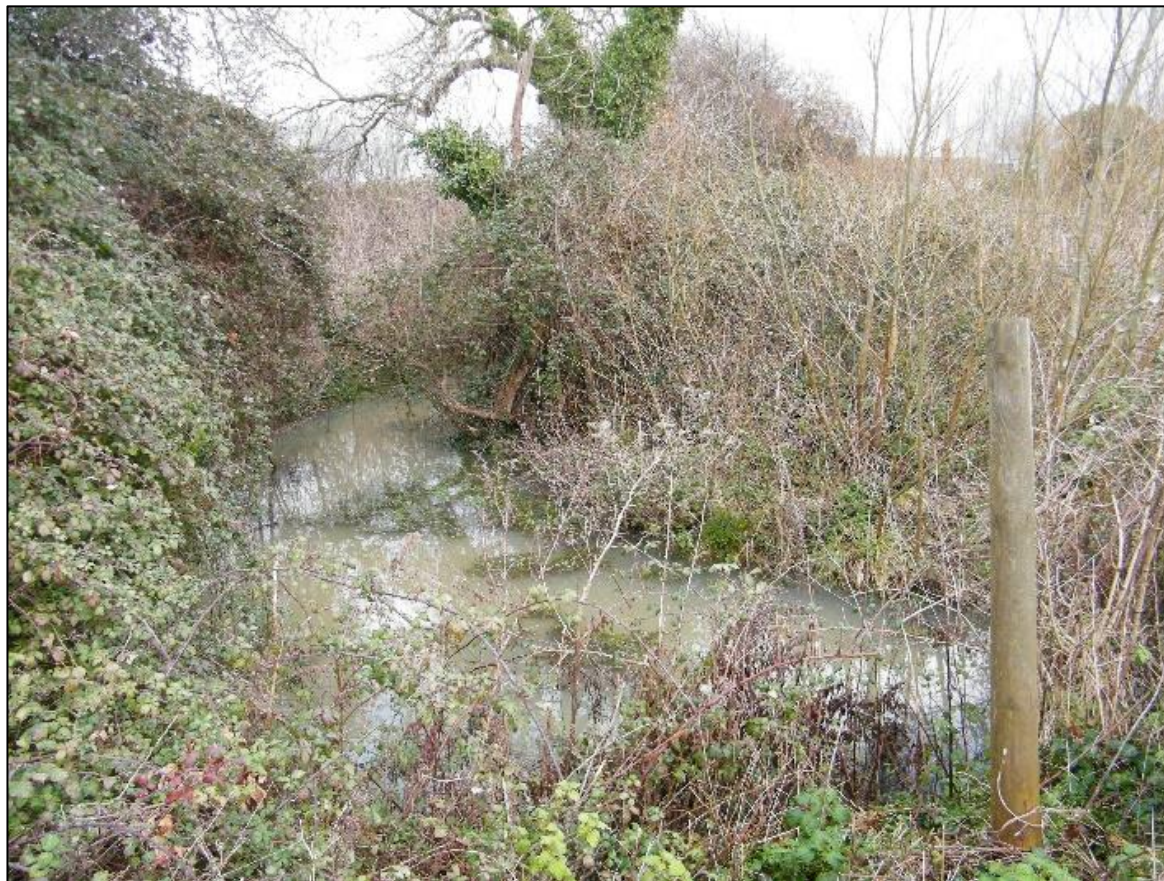
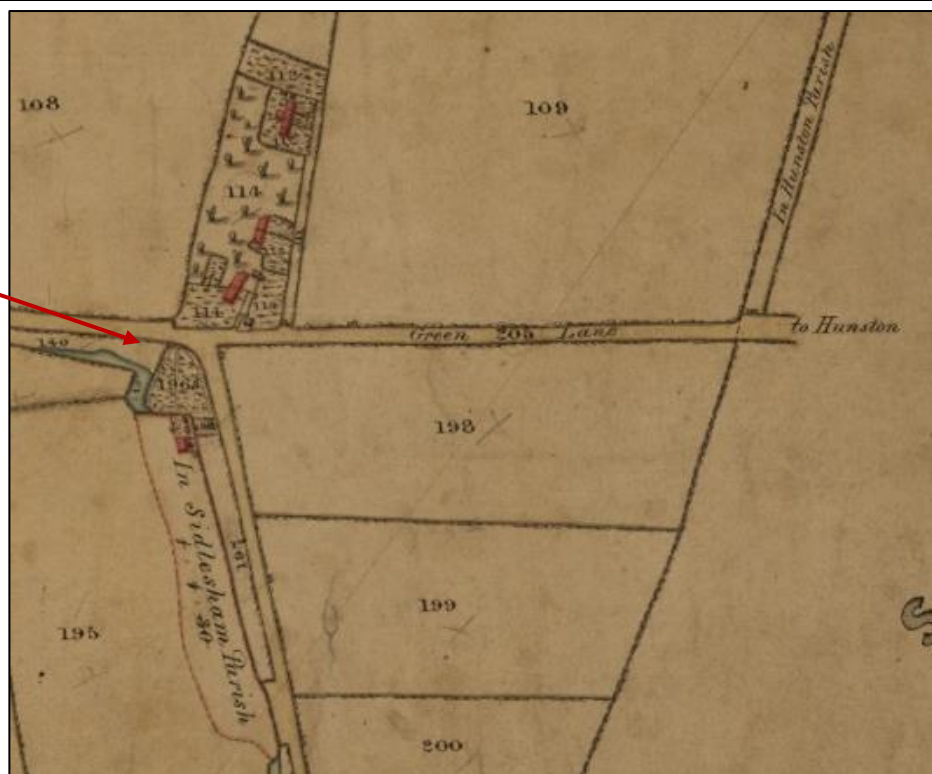
- 14. Southend Farm (SU 85054 00861) - Field corner, opposite Green Lane. There is potential to create a pond area in this large ditch and to manage the shading bramble and willow to improve biodiversity. This appears as a pond on the 1839 tithe map for the parish and may stay wet for long period creating valuable habitat and improved tanking capacity during high rainfall events.**

Relic pond on the corner of Green Lane and what is now the B2201

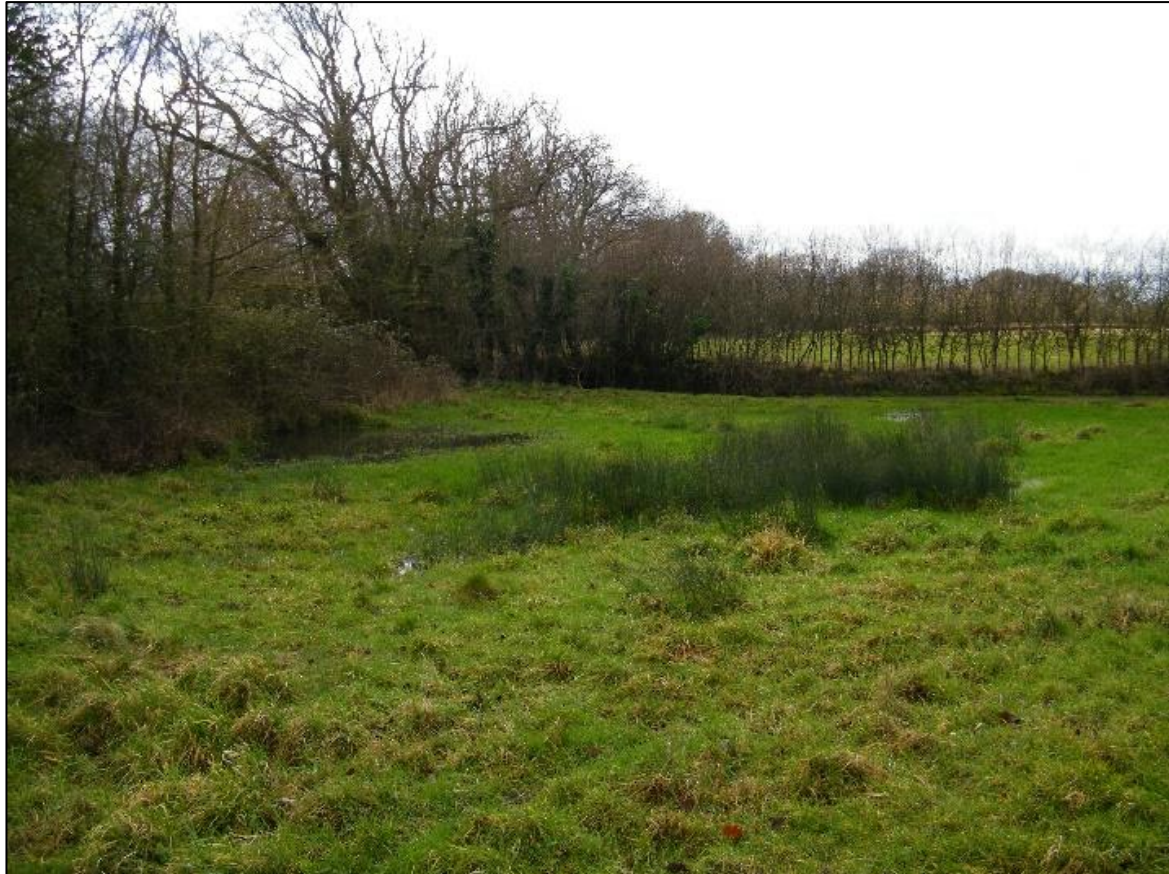
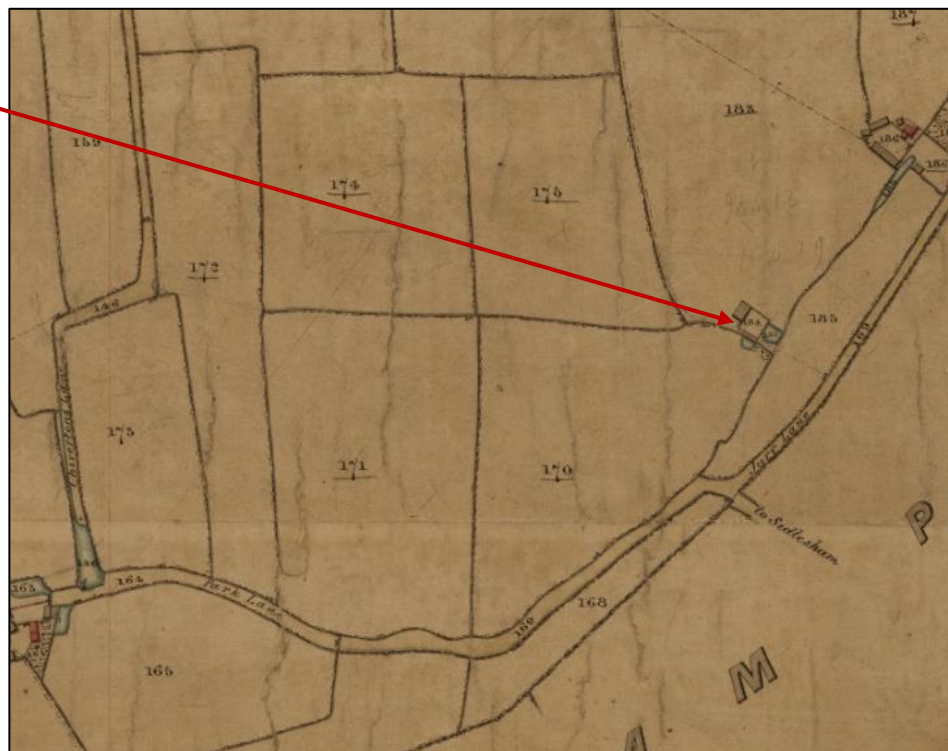
- 15. Southend Farm (SU 84629 00095)** - there is a shallowed-out ditch at the southern edge of Southend Farm, adjacent to Jury Lane, that borders an extremely wet marshy area. This site shows a pond on it on the 1838 tithe map for the parish which has been lost. Reinstating it and deepening the connecting ditches would create important wetland habitat and help to dry out the nearby road that is prone to surface water flooding.

Relic ponds now lost in marshy area

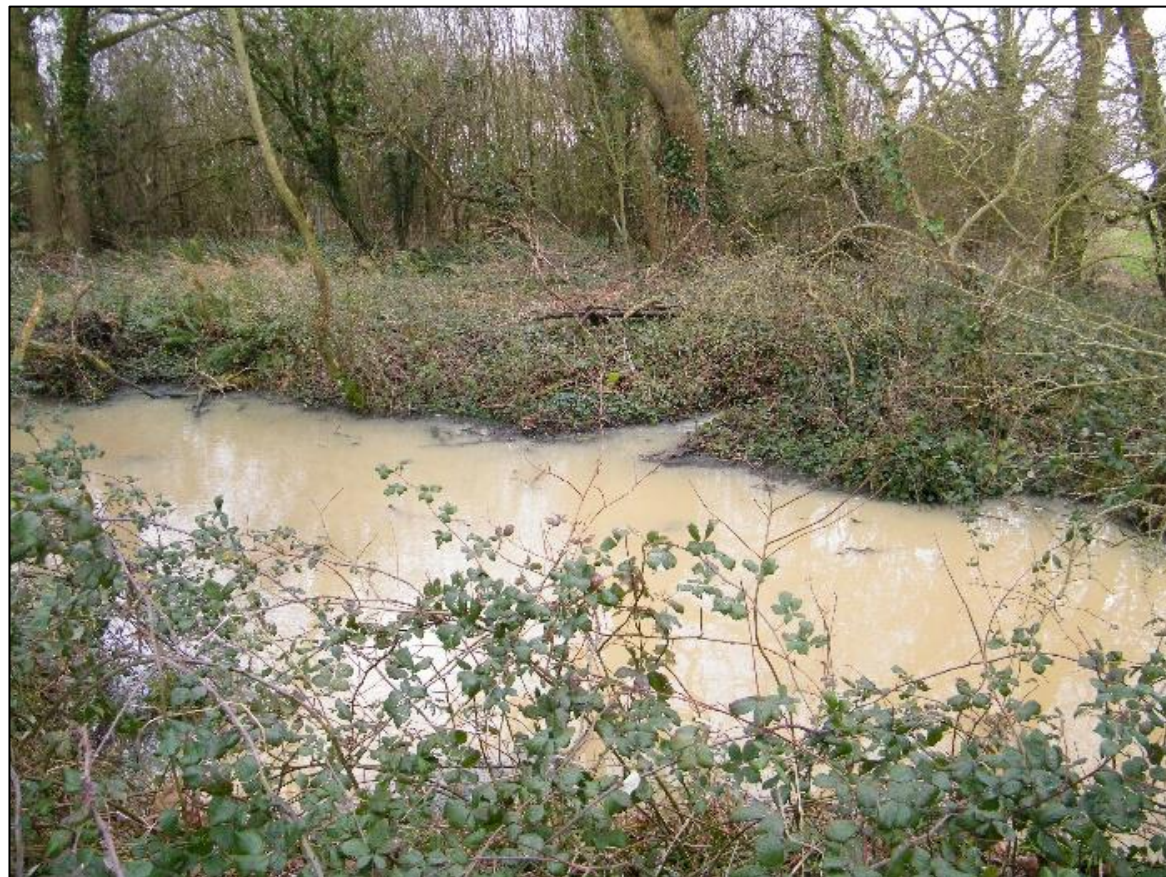
- 16. Southend Farm (SZ 84325 99962)** - this wide ditch connects to other ditches at southern edge of Southend Farm. There is an opportunity to create a large junction pond that holds water for longer. With some scrub management to get light onto the water, the biodiversity value will improve.
