Appendix iv: Photos and sections of the Donnington Parish 1839 tithe map of the sites for potential improvement

Donnington ditch condition assessment results and habitat improvement plan

Appendix iv: Photos of potential improvement opportunities
Fixing and Linking Our Wetlands

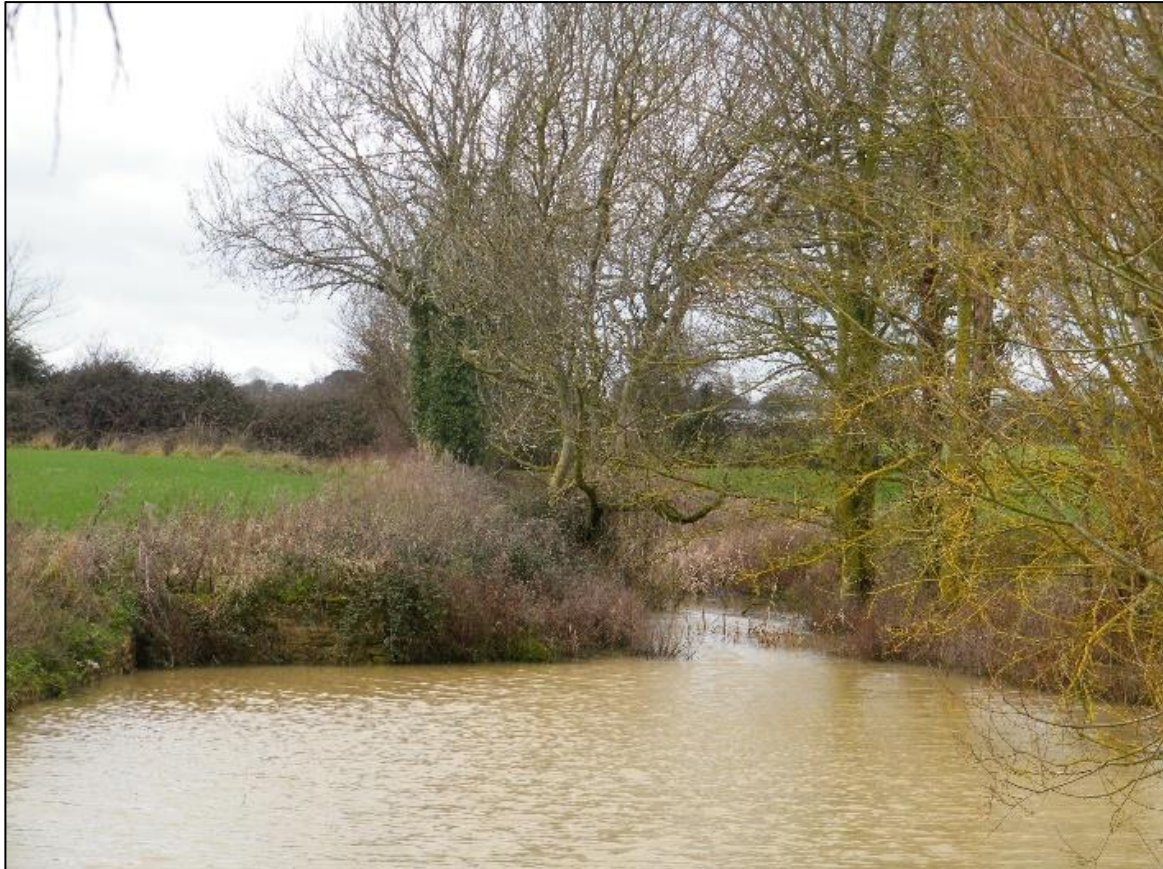
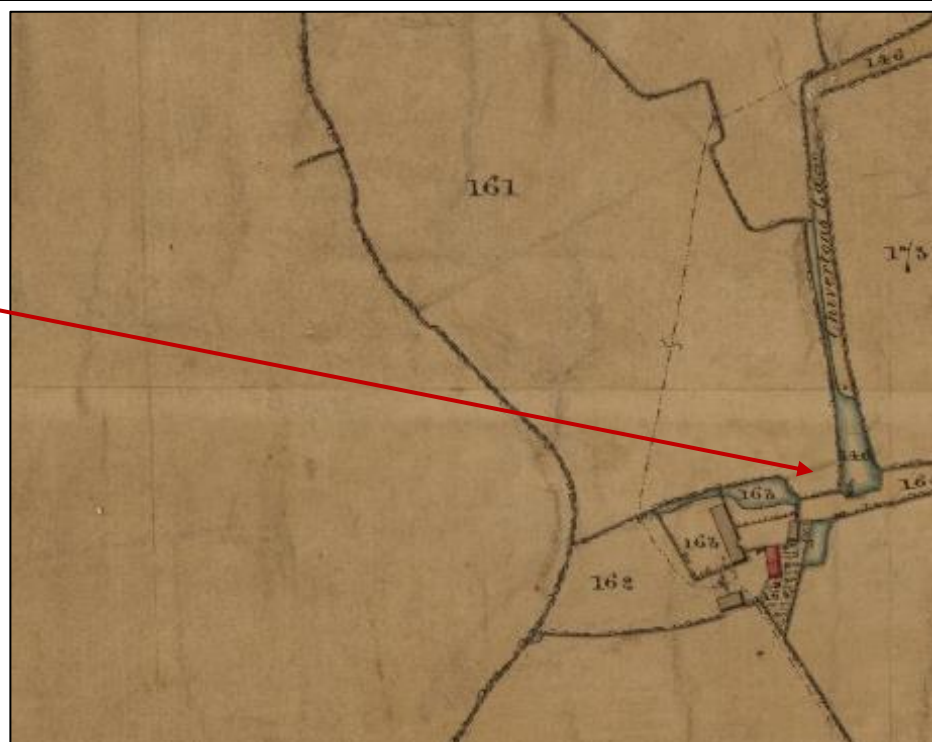
- 17. Mapsons Farm (SU 84059 00127)** - the two Eelpie Ponds are connected to ditches across the area and have potential for improvement. They appear on the 1839 tithe map for the parish when there were three of them. Hedgerows could be planted to link up the ponds and to manage the soil going into the water. The new hedgerows could also connect to the established ones on the perimeters of the fields acting as wildlife corridors. This would improve the biodiversity of the site.

Eelpie ponds – the two to the north are still evident but the one to the south is no longer present

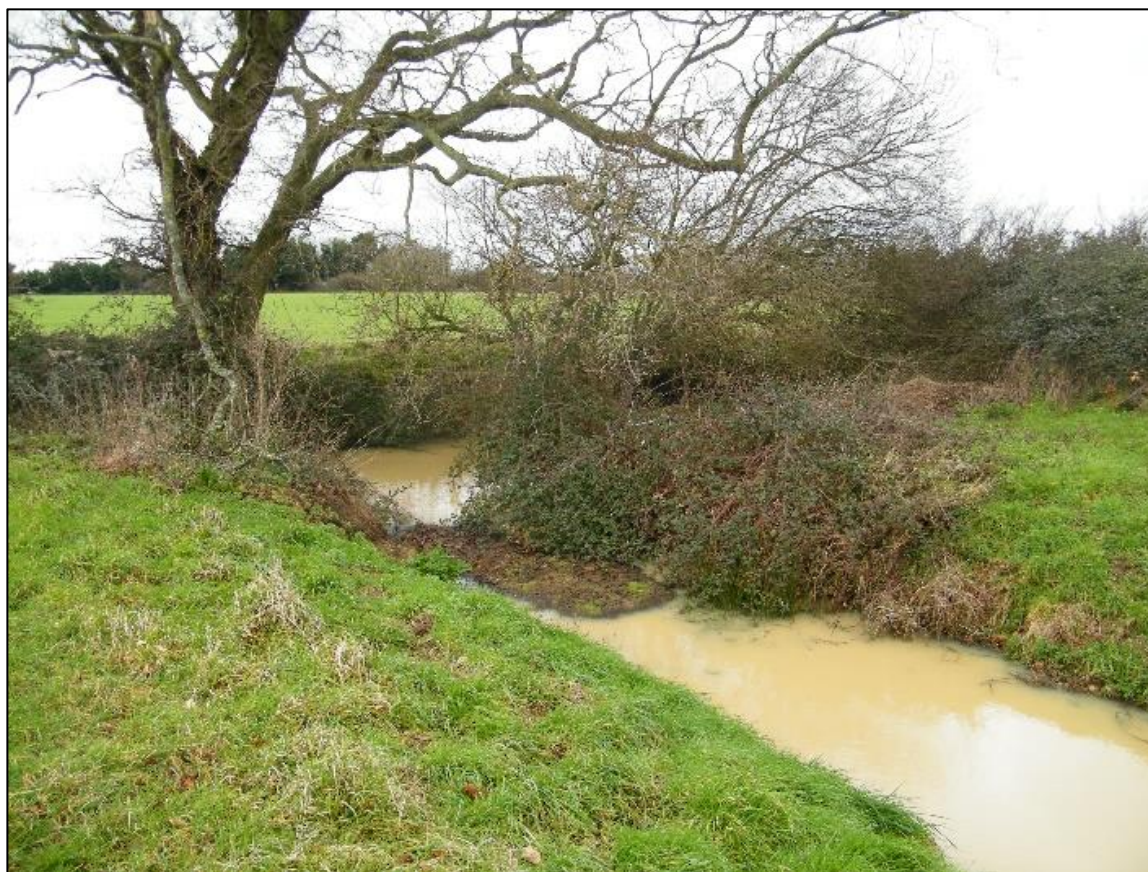
- 18. Southend Farm (SU 83883 00513)** - this ditch on the parish boundary to west of the main Southend Farm has potential to be improved at the western end. By opening up the junction of the ditches, digging it out and removing the scrub and shading tree branches, the wildlife value of the wetland and its ability to hold more water will improve.
